SOUTHERN ILLINOIS METROPOLITAN PLANNING ORGANIZATION (SIMPO) SAFETY STUDY

JUNE 17, 2019

CRAWFORD, MURPHY & TILLY, INC.
2750 WEST WASHINGTON STREET
SPRINGFIELD, IL 62702

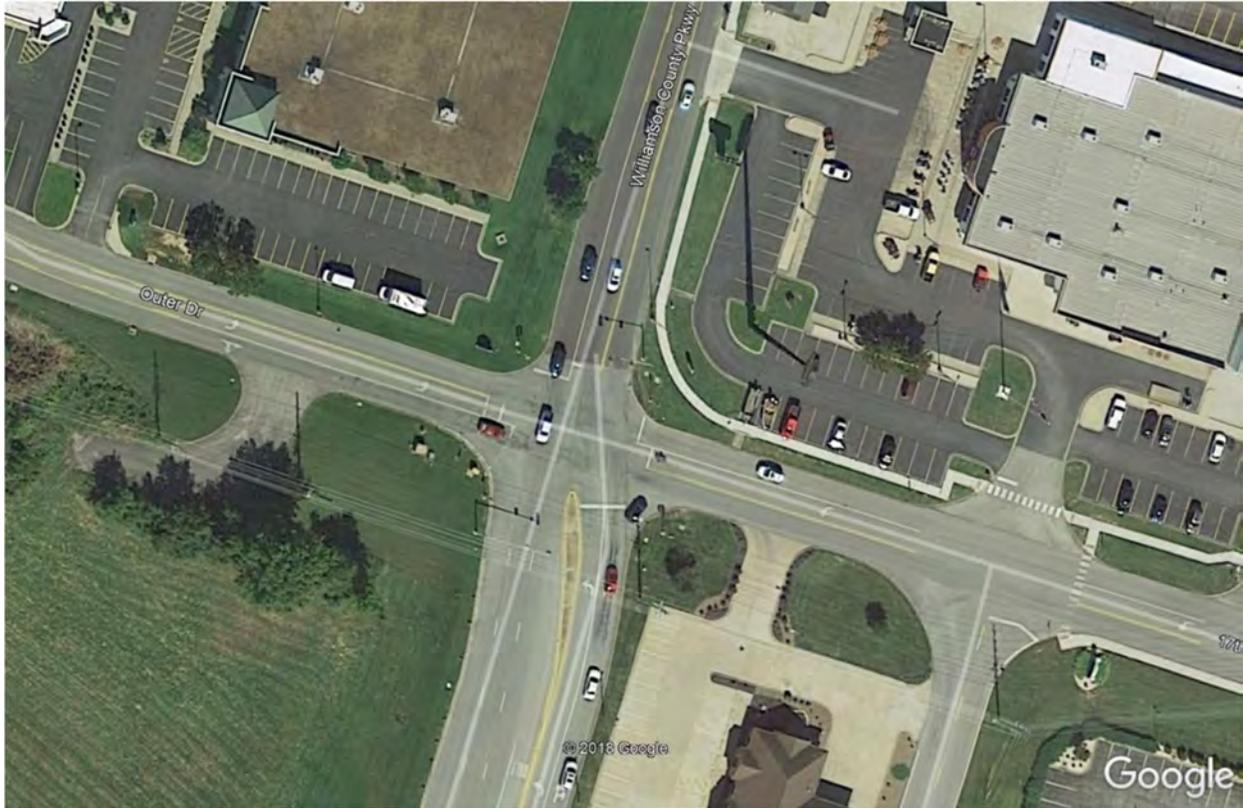
FIGURE 1: STUDY AREA

The subject intersection is a 4-leg intersection that is signalized. The adjacent land use is comprised only of commercial property. The Outer Road and 17th Street corridor serves as a parallel route to IL Route 13. **Figure 1** is an aerial view of the study area intersection.

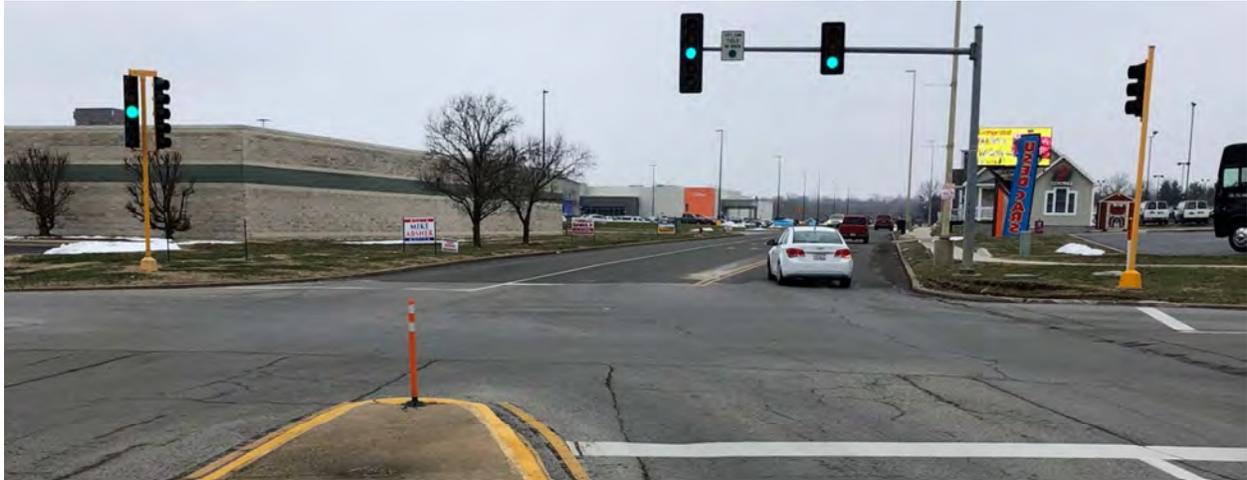
PHOTO 2: NB LEFT TURN SIGHT DISTANCE (STREET VIEW)

Photo 2 shows a perspective of a NB left turning vehicle. Vehicles in the southbound left turn lane would obstruct the view of northbound left turning vehicles.

The crash type having the greatest frequency (22 crashes or 28 percent) was attributed to the northbound left turn movement. Limited sight distance due to the alignment of the northbound approach is the primary contributing factor. Realignment of the northbound left turn lane is recommended to mitigate the left turn crashes at the signalized intersection. Capacity is expected to increase due to the reduced potential for sideswipe-meeting crashes of opposing left turn movements on Williamson County Parkway.

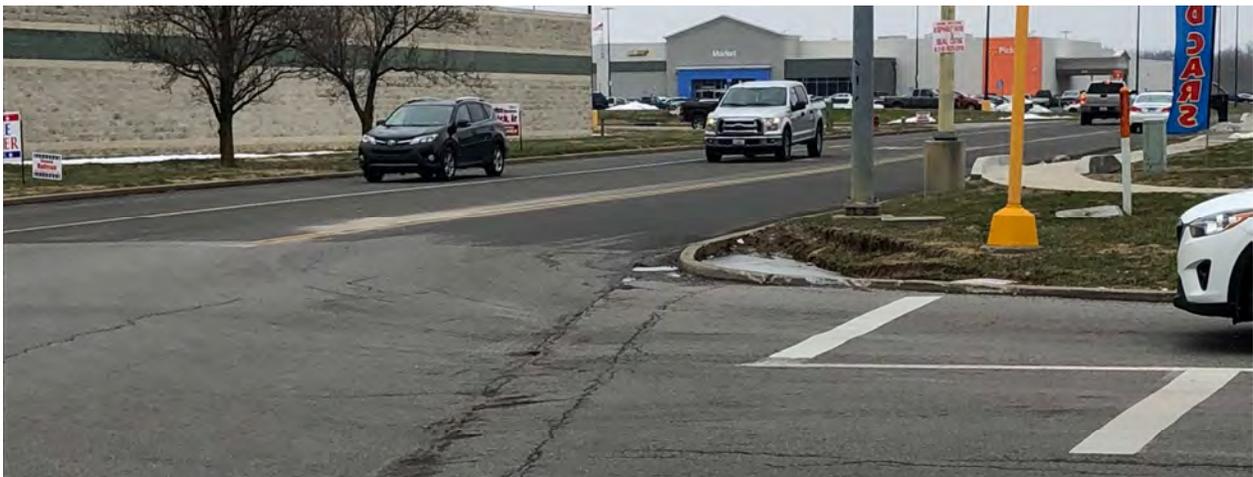
PHOTO 3: NE QUADRANT

Photo 3 shows rutting in the NE quadrant of the intersection. The curb radii are equal to 25 feet on all quadrants of the intersection. Photo 3 also shows the position of the side street stop lines being less than 10 feet from the edge of the cross street.

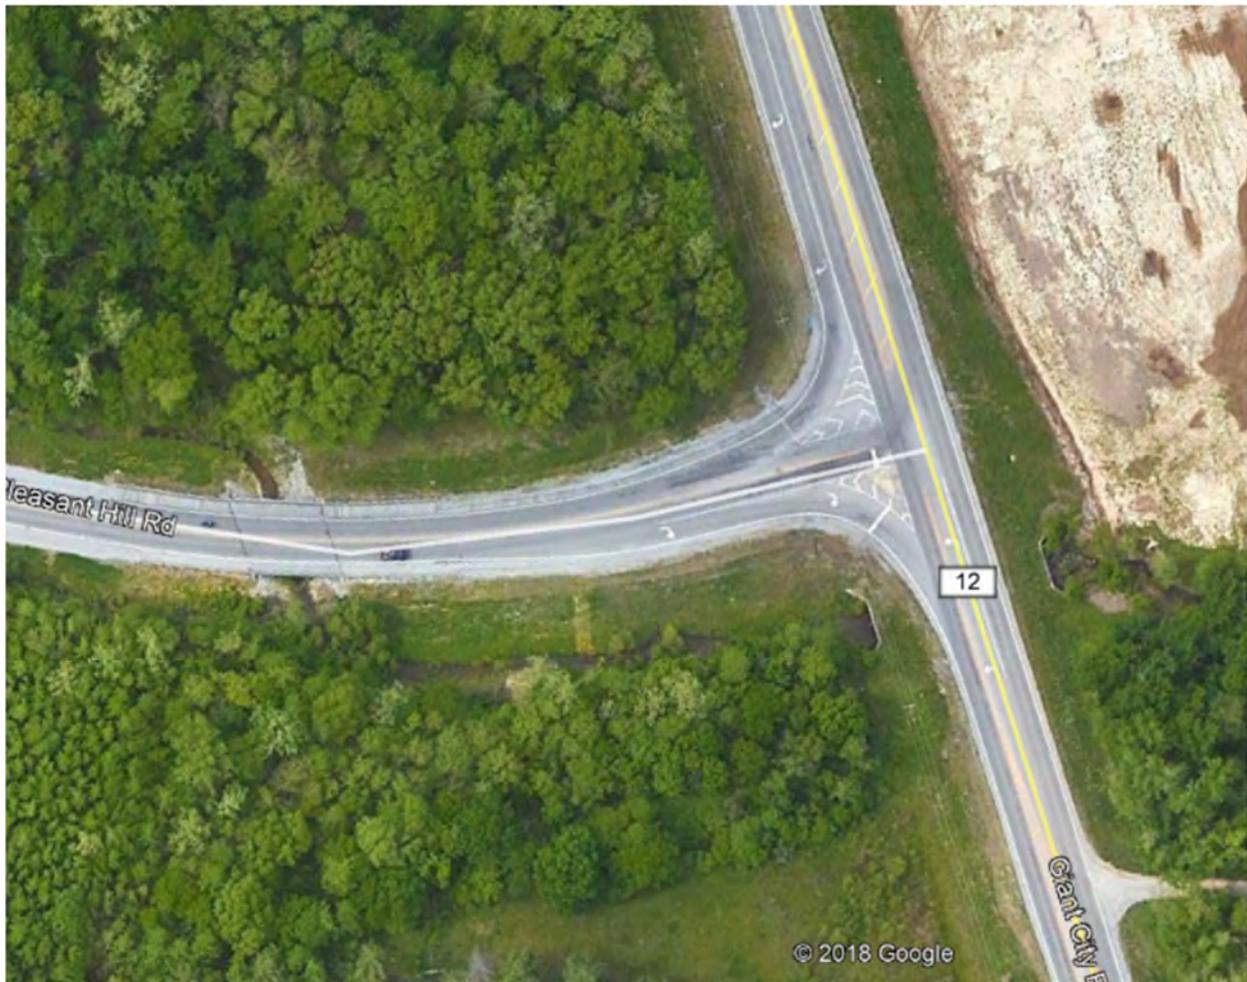
FIGURE 1: STUDY AREA

The subject intersection is a 3-leg intersection that is unsignalized. The adjacent land use is comprised of vacant or wooded property. The E. Pleasant Hill Road and Giant City Road intersection forms the southeast corner of a roadway network that serves Carbondale. **Figure 1** is an aerial view of the study area intersection.

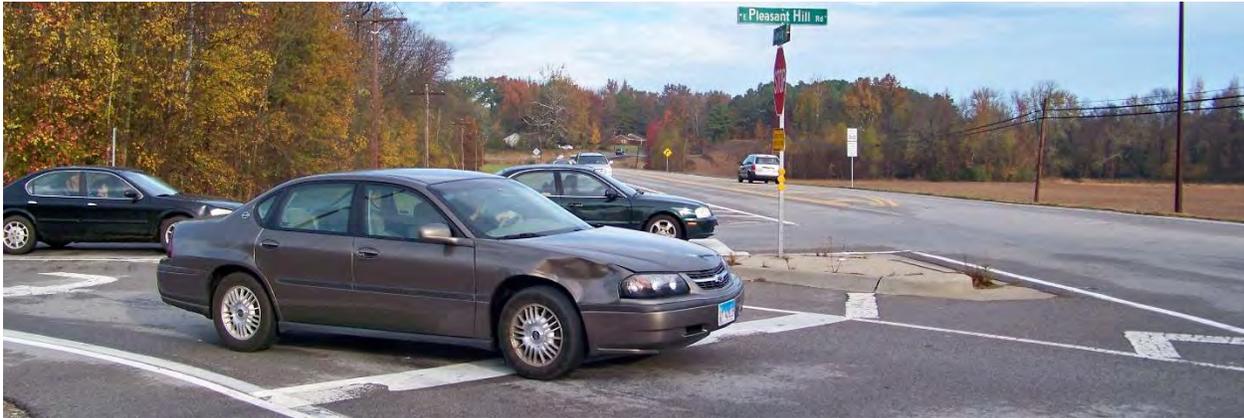
PHOTO 1: EB PLEASANT HILL ROAD LOOKING NORTH

The eastbound approach of E. Pleasant Hill Road is stop controlled. The eastbound approach has an exclusive left turn lane and an exclusive right turn movement. The posted speed limit on E. Pleasant Hill Road is 30 miles per hour. The existing conditions on the eastbound approach are summarized below:

- The stop line for the left turn lane is set back 10 feet from the edge of pavement of southbound Giant City Road. The effective turning radius of northbound left turning vehicles is 24 feet.
- The stop line for the right turn lane is located such that the intersection angle of 60 degrees exceeds the maximum allowable angle of 30 degrees for existing intersections (Section 36-1.05a). Motorists are required to turn their heads greater than 90 degrees to see southbound traffic. The vehicle shown turning right in **Photo 1** is not perpendicular to the lane markings to improve intersection sight distance angles.

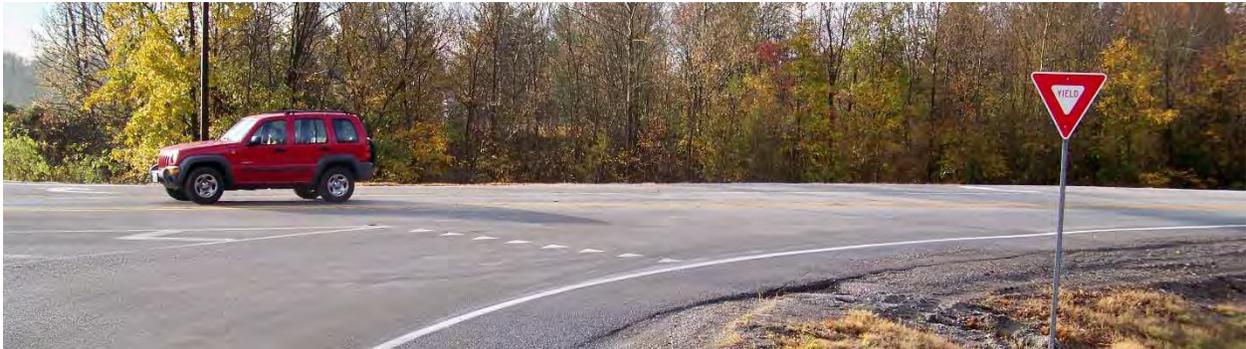
PHOTO 3: SB RIGHT TURN LANE ON GIANT CITY ROAD LOOKING SW

Photo 3 is a perspective of the southbound right turn lane looking in the southwest direction.

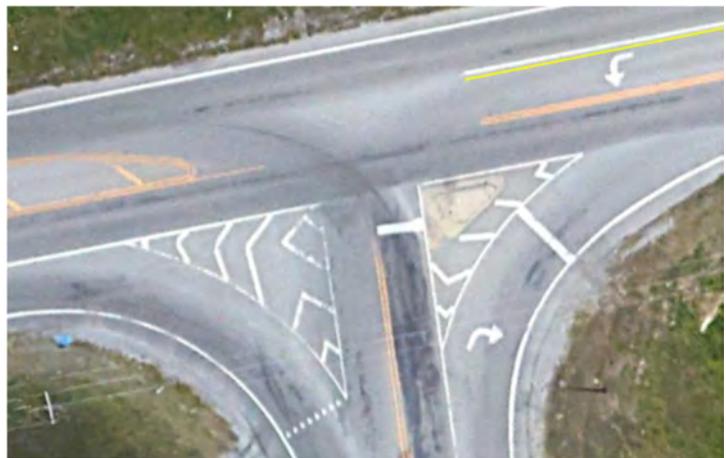
PHOTO 4: NB LEFT TURN MOVEMENT

The northbound approach of Giant City Road is uncontrolled. The northbound approach has an exclusive left turn lane and an exclusive through movement. The posted speed limit on Giant City Road is 50 miles per hour. The existing conditions on the eastbound approach are summarized below:

- The exclusive left turn lane is 285 feet long including the taper.
- The left turn yields to southbound through turning vehicles. The left turn movement regularly crosses over the painted median to reduce conflicts with eastbound left turning vehicles.

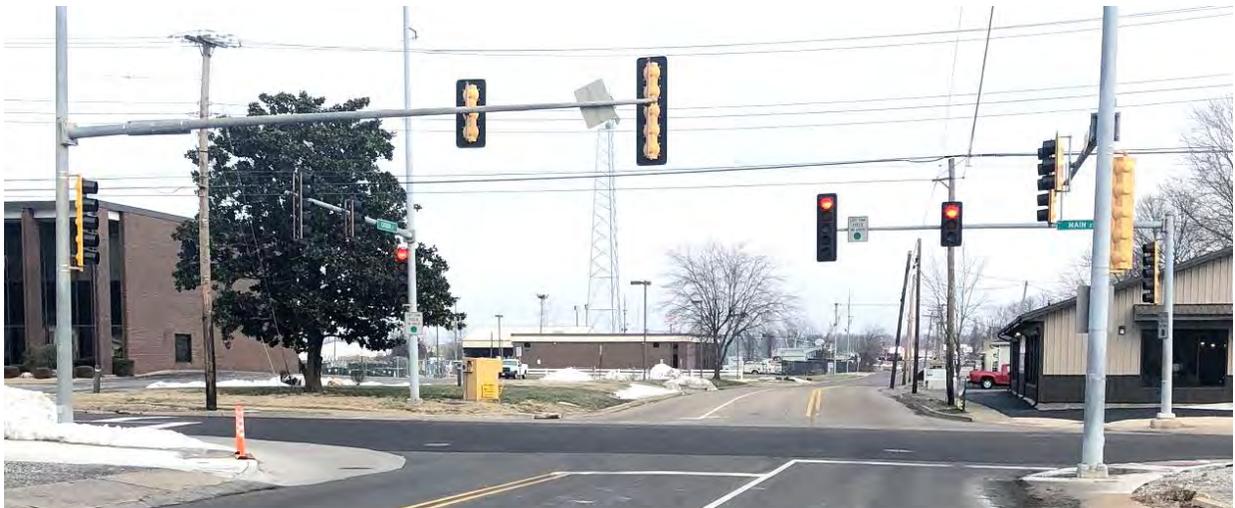
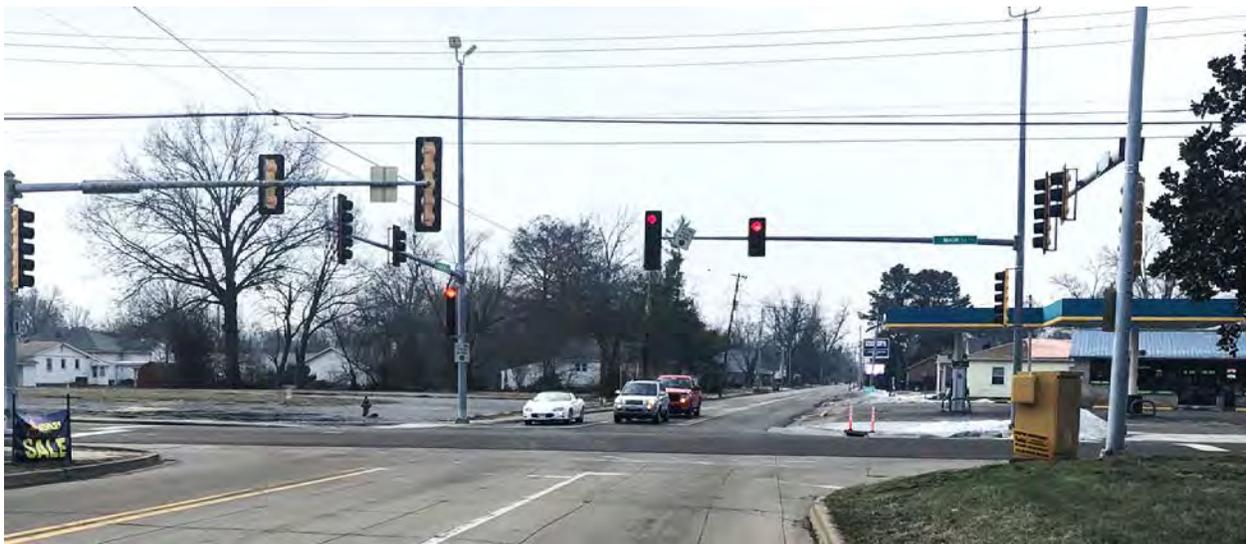
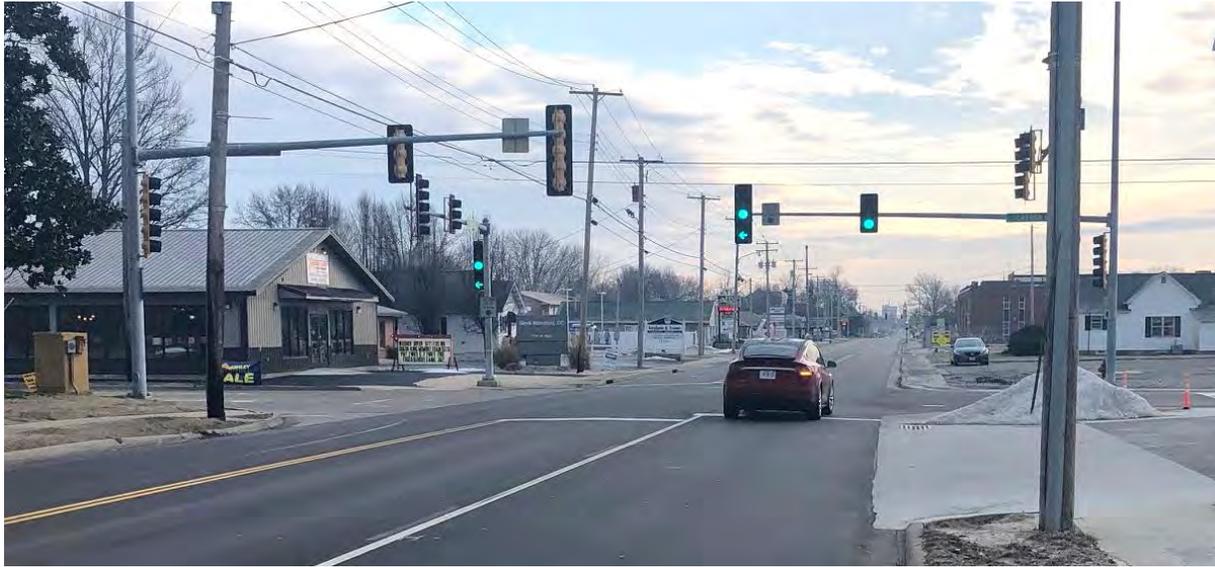
Photos 1 through 4 show a street view of each approach. All signal heads mounted overhead have backplates (without reflective edges).

PHOTO 1: NB CARBON STREET APPROACH

PHOTO 2: SB CARBON STREET APPROACH

PHOTO 3: EB MAIN STREET APPROACH

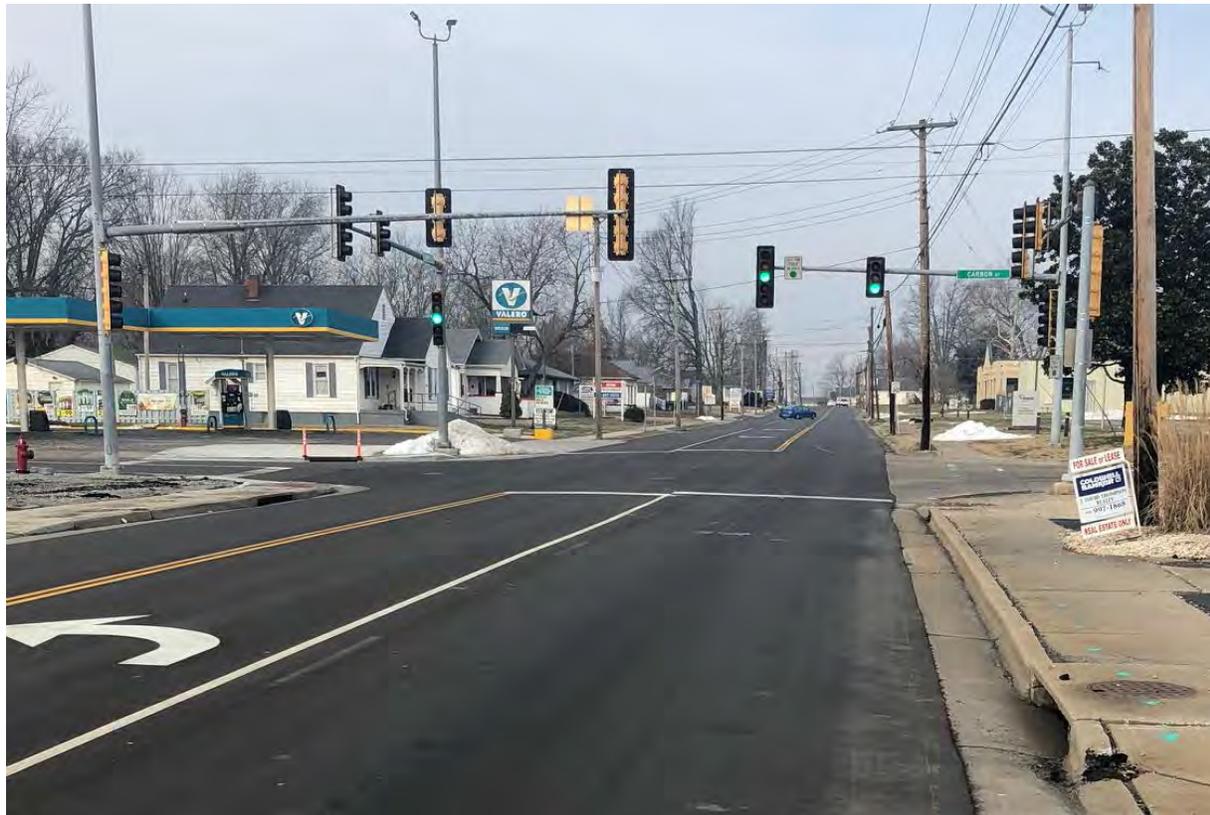
PHOTO 4: WB MAIN STREET

The supplemental sign indicating that the Left Turn Must Yield on Green is missing on the signal support on the westbound Main Street approach.

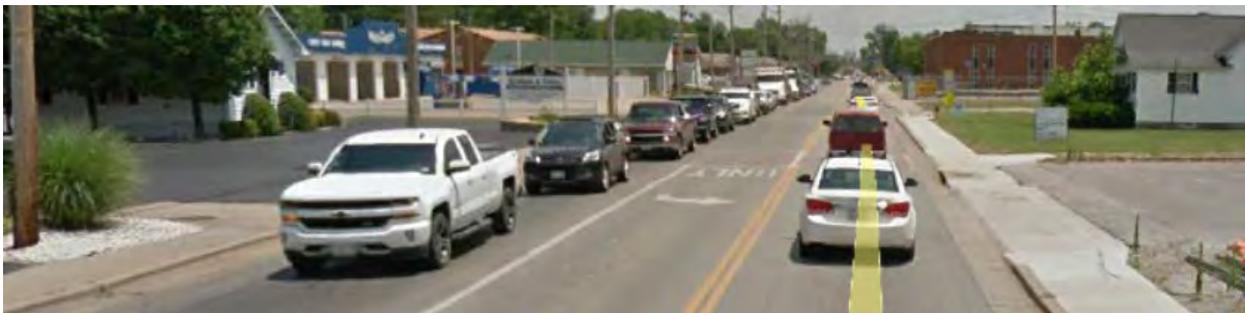
PHOTO 5: WB MAIN STREET QUEUE

Signal timing to balance delays may also be desirable to mitigate the crashes on Main Street. **Photo 5** shows a Google street view of queues formed on westbound Main Street. **Photo 6** shows the longest queue that formed on Carbon Street during field observations. No vehicles were on the southbound Carbon Street approach. Additional green time may be desirable to reduce queue lengths which may be a factor for rear end crashes. To reduce queues, vehicle detection is recommended for all left-turn phases (and removal of the recalls) and the northbound approach to the intersection (at a minimum). Appropriate vehicle detection is also shown to reduce rear end crashes caused by prematurely ending a green phase.

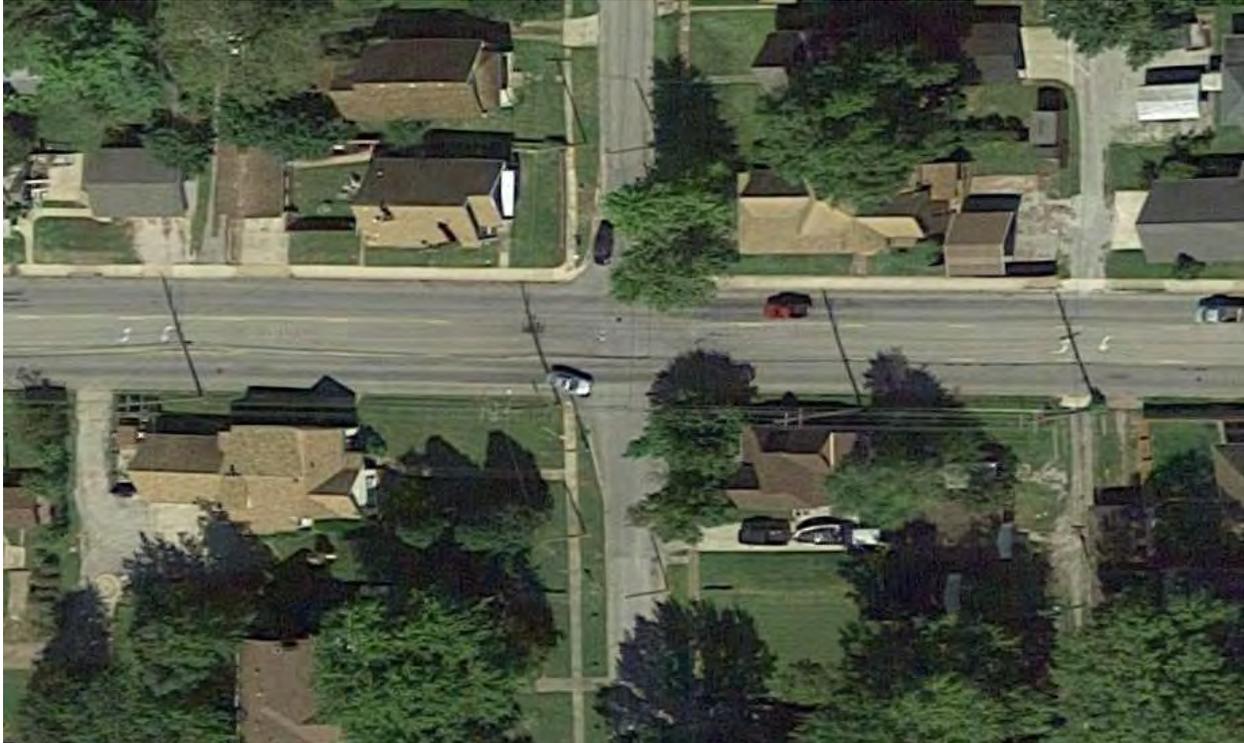
FIGURE 1: STUDY AREA

The subject intersection is a 4-leg intersection with E. Herrin Road an east/west route and 13th Street a north/south route. The adjacent land use is comprised of residential property. The Herrin Hospital is located 0.70 south of the intersection. The Herrin High School is located 700 feet east of the intersection. **Figure 1** is an aerial view of the study area intersection.

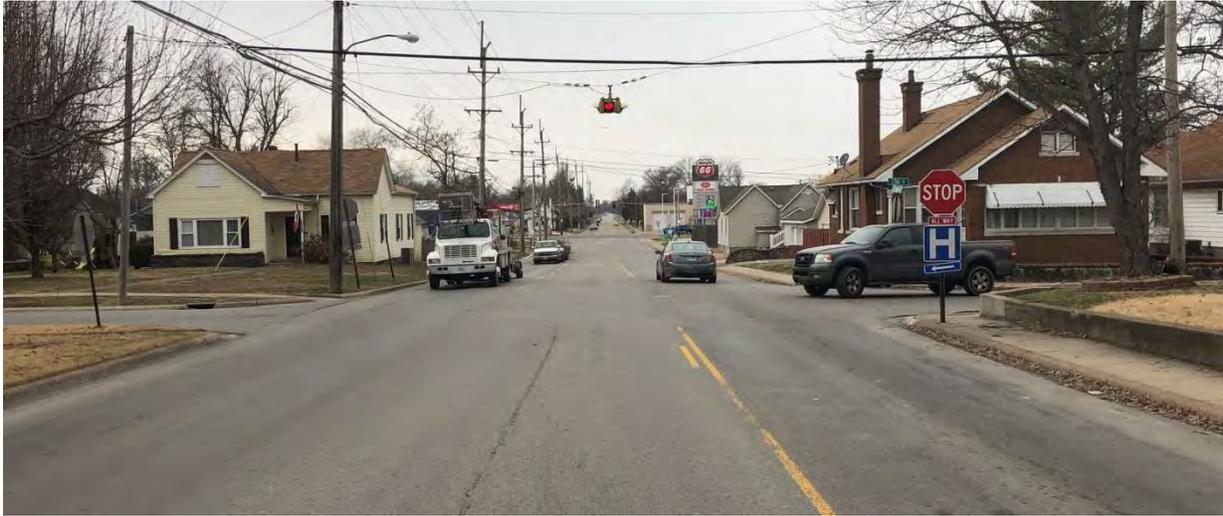
PHOTO 1: WB HERRIN ROAD

- E. Herrin Road is a 3-lane roadway having a center two way left turn lane (TWLTL). The posted speed on E. Herrin is 30 MPH. **Photo 1** shows the westbound approach of the stop-controlled intersection.
- 13th Street is a local residential street with a posted speed of 25 MPH. **Photo 2** shows the northbound approach of the stop-controlled intersection.
- The 4-way stop control is supplemented with a single lens beacon that flashes red.
- No stop lines exist on any approach. The use of stop lines is not required.
- The average daily traffic (AADT) is 7,300 vehicles per day on E. Herrin Road. The AADT on 13th Street is 2,050 vehicles per day.
- No Stop Ahead signs exist on any approach.

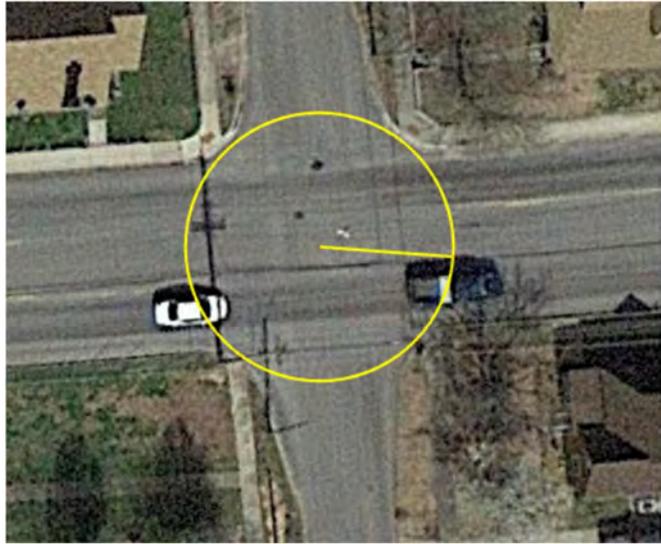
FIGURE 7: HERRIN/ 13TH STREET FOOTPRINT

Figure 7 shows a circle with a 30 ft radius at the E. Herrin Road and 13th Street intersection that is representative of the size of a mini-roundabout. An FHWA study of mini-roundabouts was concluded in 2016. One of the study locations was Tollgate Road and MacPhail Road in Bel Air, Maryland. A plan of the Maryland design is shown in **Figure 8**. The inscribed radius shown on the plan is 30 feet.

The E. Herrin Road and 13th Street intersection could be converted to a mini-roundabout design. A mini-roundabout is a smaller footprint of a typical roundabout that permits the mounting of the central island and minimizes/avoids property impacts. The characteristics that are suitable for a mini-roundabout:

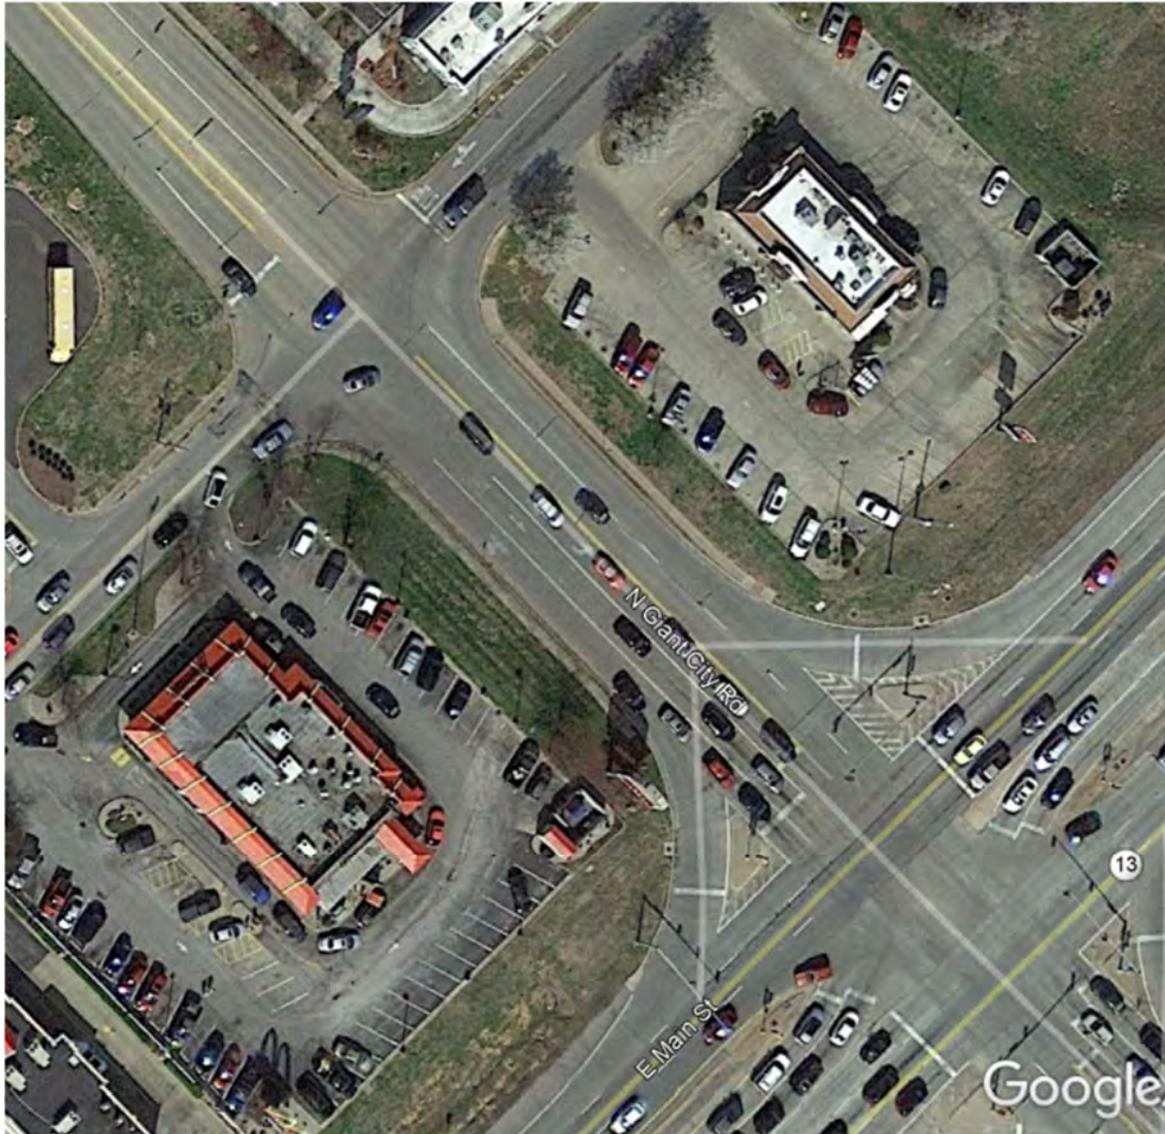
FIGURE 1: STUDY AREA

The unsignalized 4-leg intersection is located 250 feet from the signalized intersection of Giant City Road and IL Route 13. The adjacent land use is comprised only of commercial property. The Frontage Road corridor serves as a parallel route to IL Route 13. **Figure 1** is an aerial view of the study area intersection.

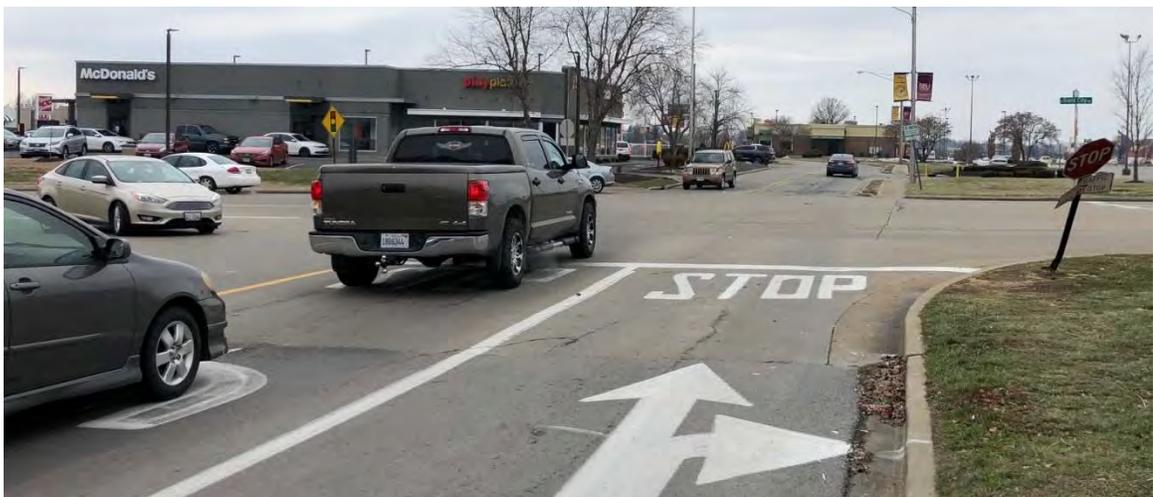
PHOTO 2: WB FRONTAGE ROAD

- **Westbound Frontage Road.** Two lane approach with an auxiliary left turn lane. The approach is stop-controller. Note stop sign condition on **Photo 2**. A supplemental warning sign exists under the Stop Sign which reads “Traffic From Left Does Not Stop.” Pavement markings were recently upgraded. Single line centerline exists on the westbound approach. The aerial view of **Figure 1** shows the centerline pavement markings were worn/not existent.

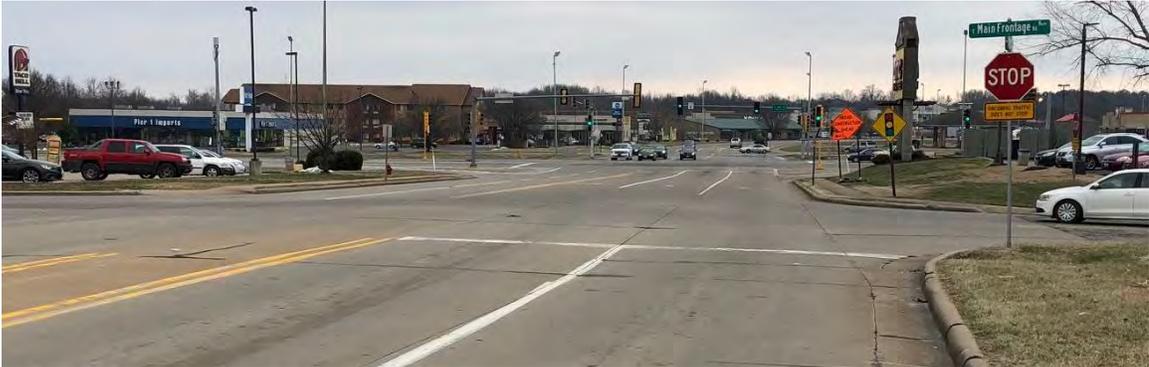
PHOTO 3: SB GIANT CITY ROAD

- **Southbound Giant City Road.** The two-lane approach has a shared through-right lane and a shared through-left lane. The shared through left turn lane is offset from the opposing through movement by 9 feet – the width of the painted median. The approach is stop controlled. Note the proximity of the signalized intersection at IL Route 13. See **Photo 3**.

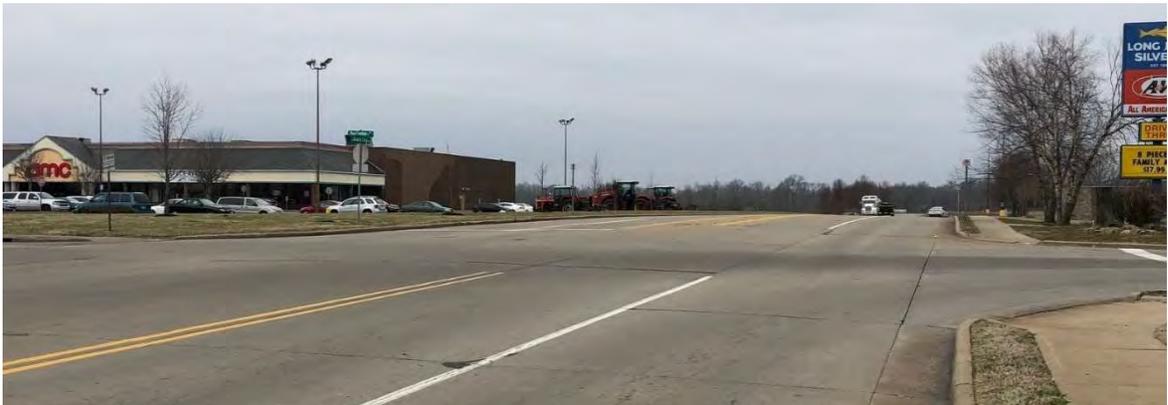
PHOTO 4: NB GIANT CITY ROAD

- **Northbound Giant City Road.** The two-lane approach has a shared through-right lane and a shared through-left lane. The approach has right of way (no stop control). See **Photo 4**.

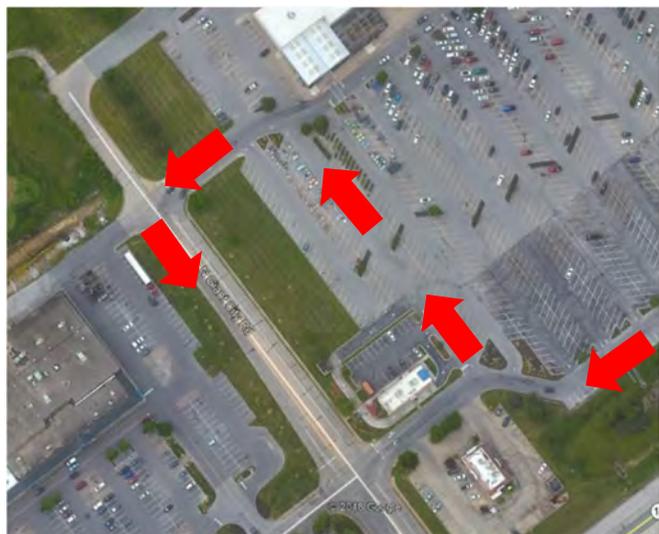
FIGURE 10: ON-SITE WAYFINDING

The roundabout could be constructed as part of a future phase. The westbound approach of the Frontage Road intersection would be most impacted. Wayfinding signs could be added on westbound Frontage Road to direct traffic destined to IL Route 13 to turn north along a drive aisle on the Wal-Mart property to minimize the need for a roundabout for U-turn movements. See **Figure 10**.

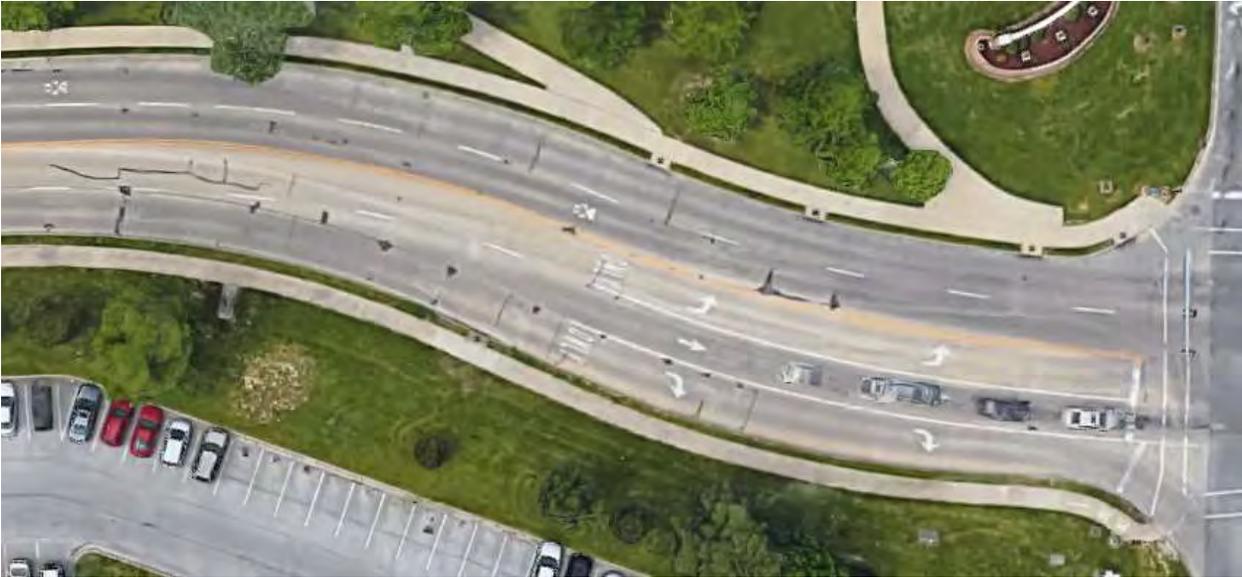
FIGURE 2: HORIZONTAL CURVES AND LANE CONFIGURATION (GRAND AVE)

The alignment of the west leg is comprised of an S-curve (see **Figure 2**). The existing EB lane configuration at the intersection drops the inside through lane directly into the EBLT lane.

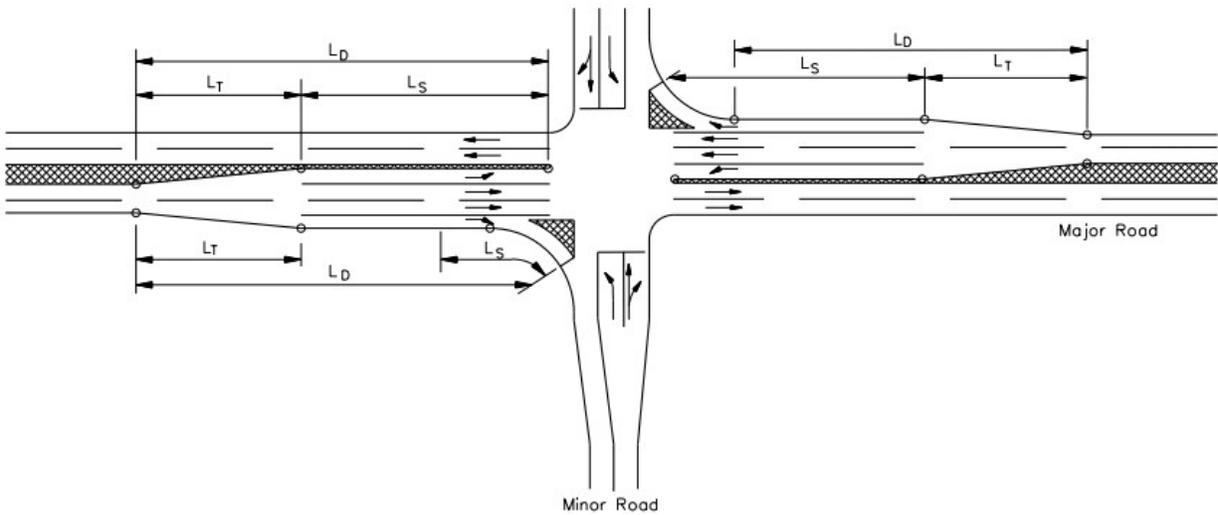
FIGURE 8: IDOT BDE MANUAL FIGURE 36-3.H

2. Add overhead advance lane use signing to delineate the lane designations 250' in advance of the intersection.
3. Add reflective strips to the backplates on the vehicular signal heads at the intersection to further increase visibility. Research shows this improvement results in a 15% reduction in crashes.
4. Add Wavetronix advance radar detection to detect approaching platoons and effectively eliminate the dilemma zone caused by indecision when the yellow indication is displayed (some cars stop, some accelerate, causing rear-end crashes).

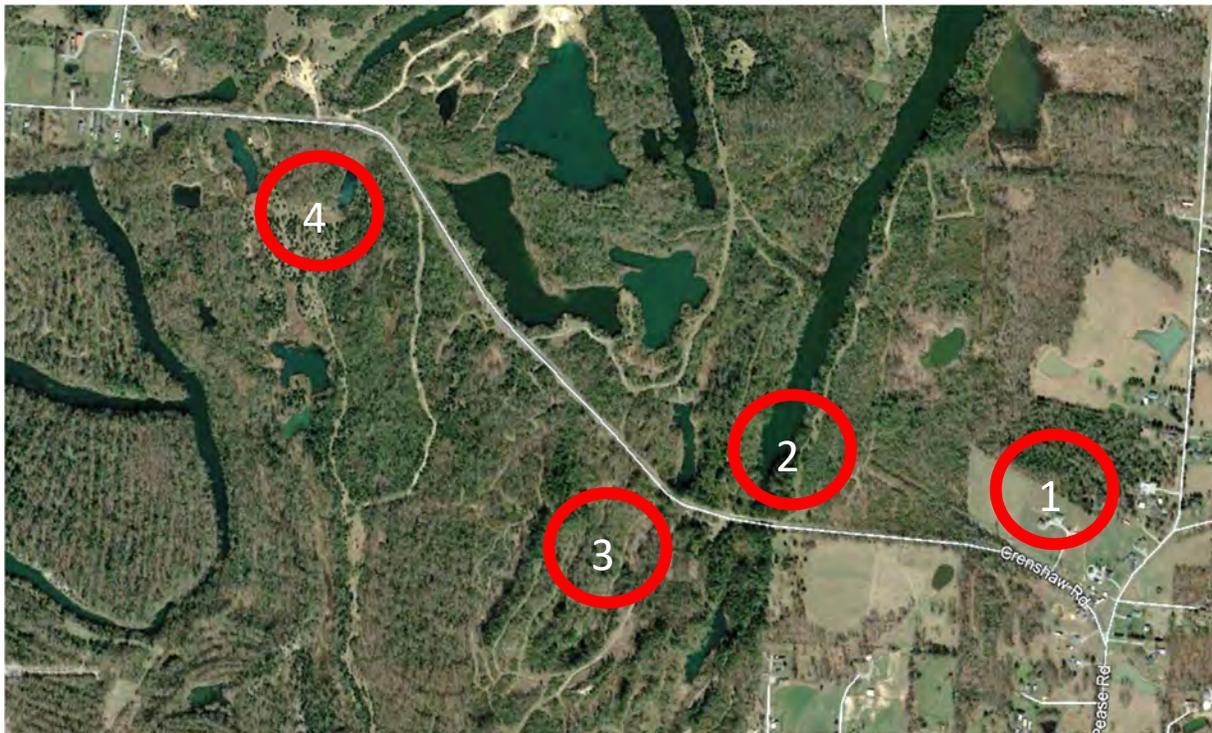
FIGURE 1: STUDY AREA

Crenshaw Road is a roadway having variable width between 16 and 24 feet. Aggregate shoulders vary between 0' and 2' in width. The roadway does not have any pavement markings or warning signs with the exception of a single chevron about 300 feet west of the Pease Road intersection. **Photos 1-4** show the existing horizontal and vertical curves within the study area. The approximate location of each photo is numbered on **Figure 1**. The approximate distance from Pease Road is referenced for each photo.

Williamson County has installed chevrons on Crenshaw Road since the study was initiated. The chevrons are located on the curves #1, #3, and #4 (**Figure 1**) which are the horizontal curves having the greatest deflection. **Photo 10** shows new chevrons along Curve #4 as shown in **Figure 1**.

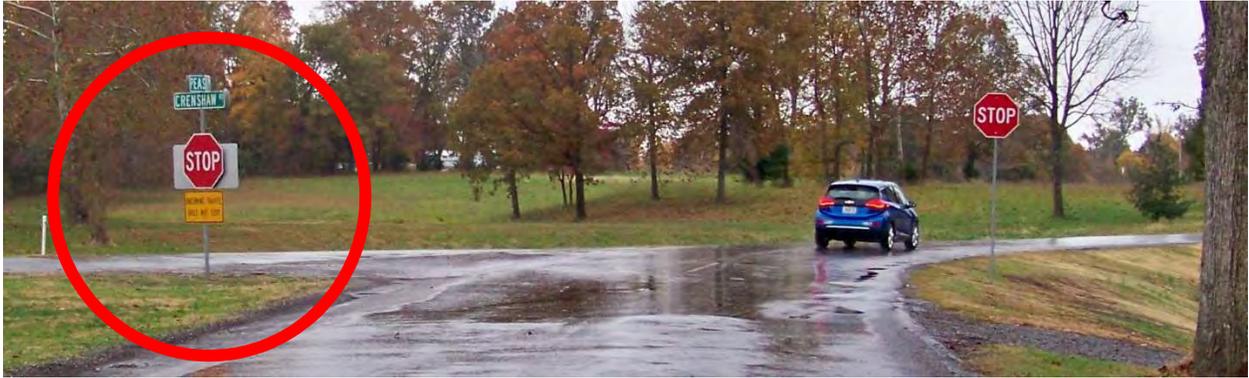
PHOTO 5: EB CRENSHAW RD APPROACH AT PEASE ROAD INTERSECTION

The Pease Road and Crenshaw Road intersection has 3-legs and is configured as a Y-intersection. The stem of the Y-intersection (Pease Road) has right of way whereas the SB Pease Road approach and the EB Crenshaw Road approach are stop controlled approaches. **Photo 5** shows the EB Crenshaw Road approach. The red circle is the stop sign for the SB Pease Road approach. The large arrow warning sign for the NB Pease Road approach obscures the shape of the stop sign. **Photo 6** shows NB Pease Road.

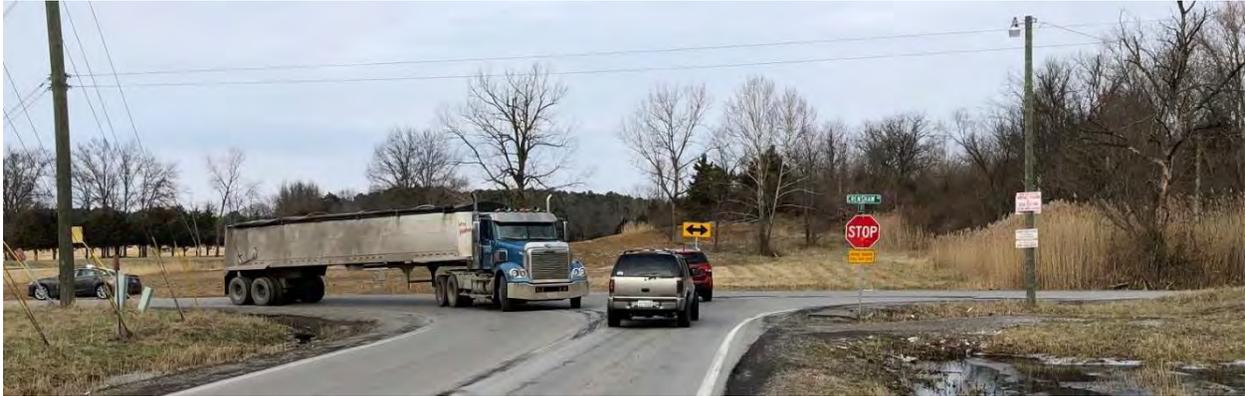
PHOTO 7: NB SKYLINE ROAD AT CRENSHAW ROAD INTERSECTION

Skyline Road and the west leg of Crenshaw Road are part of a Class III truck route. Traffic volumes are higher for the following movements: EB right turn and NB left turn. **Photo 7** shows a typical truck turning from EB Crenshaw Road to SB Skyline Road.

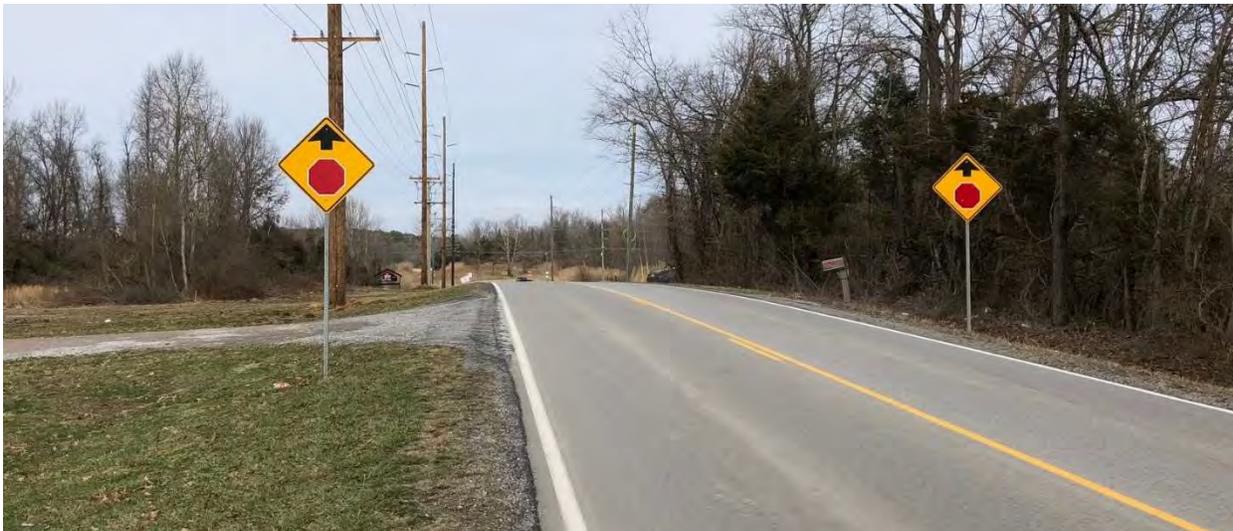
PHOTO 8: NB SKYLINE ROAD APPROACH (@ 750 FT IN ADVANCE OF CRENSHAW)

Stop Ahead signs (W3-1) are located 750 feet in advance of the Skyline Road and Crenshaw Road intersection. A vertical curve on Skyline Road in advance of the intersection may reduce the available stopping sight distance for queues of vehicles stopped ahead on Skyline Road, as shown on **Photo 8**. A Be Prepared to Stop (W3-4) sign is located 1,350 feet in advance of Crenshaw Road (**Photo 9**).

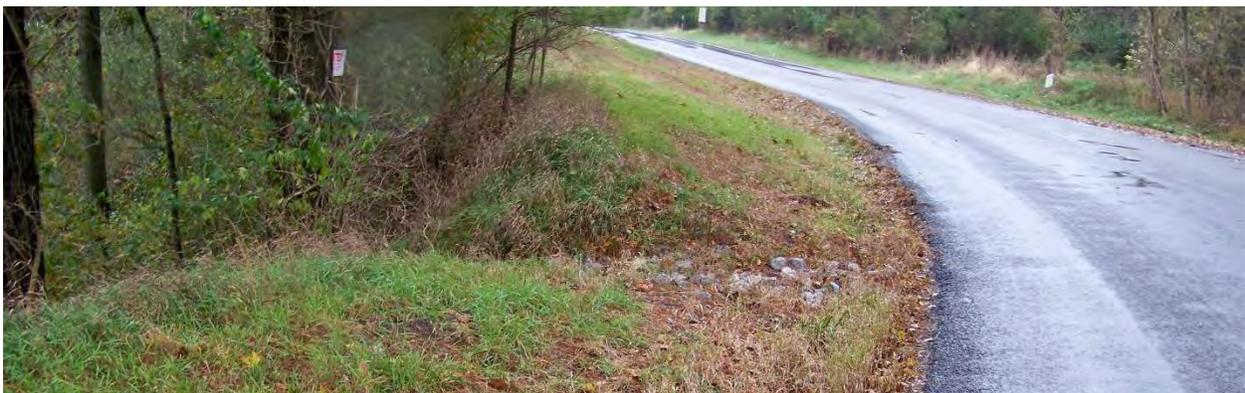
PHOTO 12: CLEAR ZONE AT CURVE #3

Guardrail may be considered at the location of Curve #3 as shown on **Figure 1**. **Photo 12** shows the drop off that is located less than 10 feet from the edge of pavement.

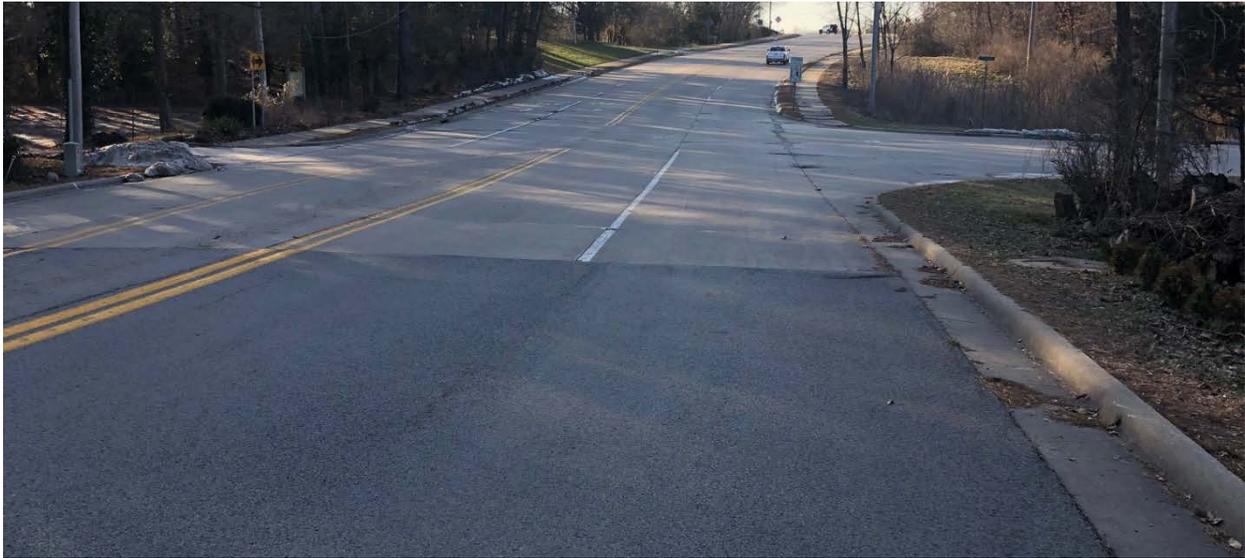
PHOTO 3: WB E. PLEASANT HILL ROAD AT WALL STREET

E. Pleasant Hill Road is a curbed roadway having an overall width of 31 feet from back to back of curb. A double yellow centerline is the primary pavement marking with the exception of the westbound approach to Wall Street -- a second westbound lane and a painted median is added to shadow an opposing left-turn lane (**Photo 3**). The eastbound approach of the E. Pleasant Hill and Wall Street intersection has an exclusive left-turn lane and a through lane.

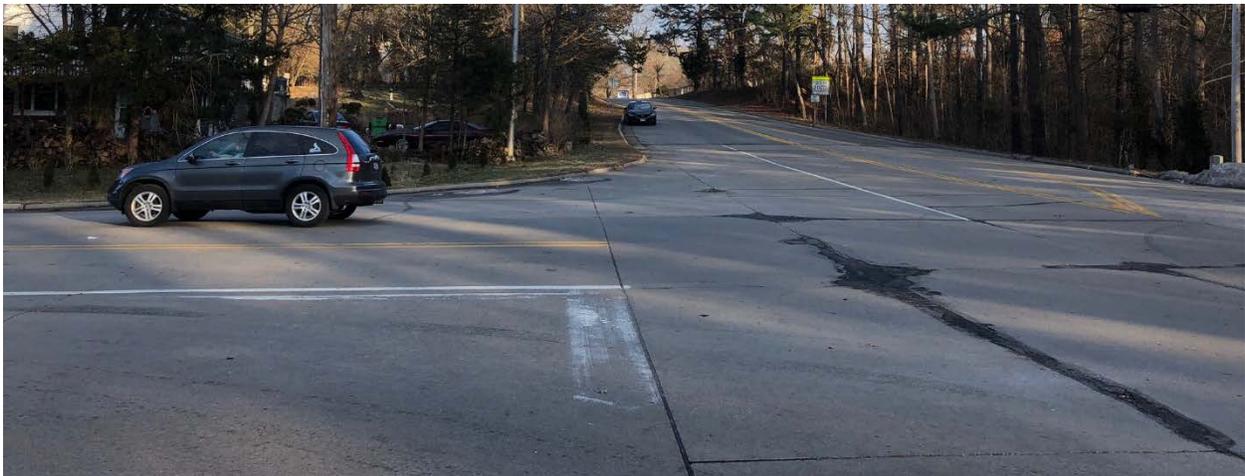
PHOTO 4: WALL STREET STOP LINE (RIGHT LANE ONLY)

The posted speed limit on E. Pleasant Hill Road, Warren Road, and Wall Street is 30 miles per hour within the study area. The speed limit is 20 miles per hour within a 600 ft segment near the Wall Street intersection. Field observations noted operating speeds are higher than the posted speed limit.
