SOUTHERN ILLINOIS METROPOLITAN PLANNING ORGANIZATION (SIMPO) SAFETY STUDY

JUNE 17, 2019

CRAWFORD, MURPHY & TILLY, INC.
2750 WEST WASHINGTON STREET
SPRINGFIELD, IL 62702

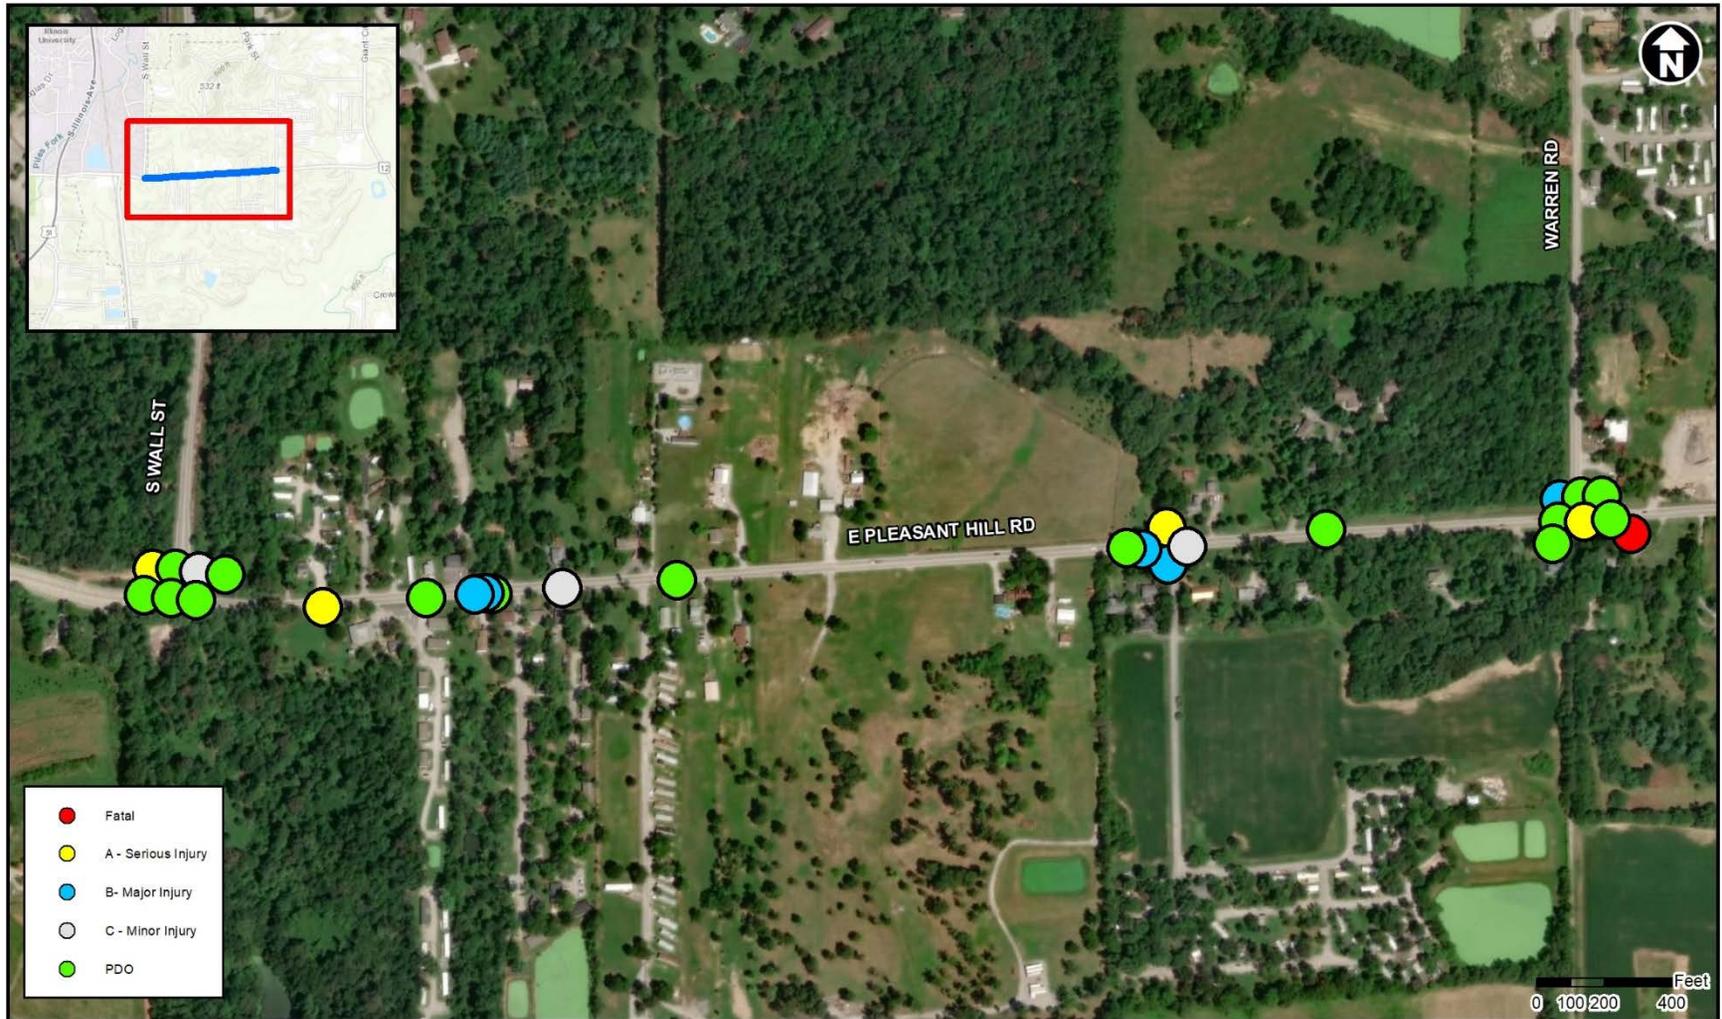
FIGURE 6: CRASH SEVERITY AND LOCATION MAP

Figure 6 shows the location and severity of crashes plotted on an aerial map of the study area.

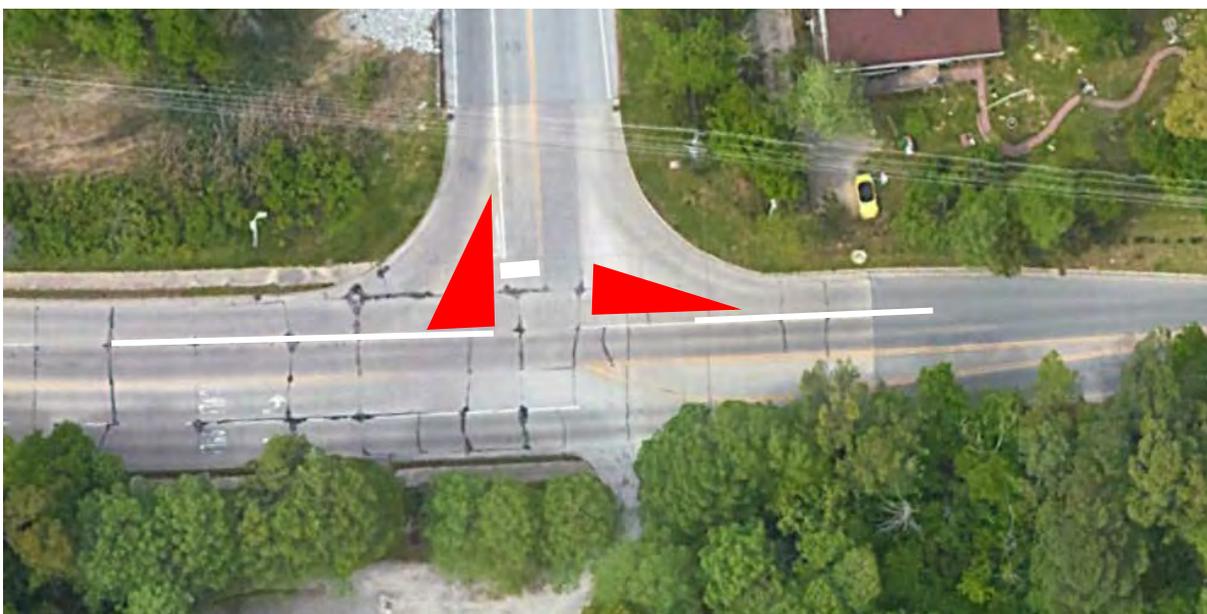
FIGURE 8: WALL STREET COUNTERMEASURE

Figure 9 shows a schematic plan of the proposed improvements to the E. Pleasant Hill Road and Wall Street intersection. Dual stop signs can be mounted on the raised medians for the Wall Street approach. Yield signs can be installed for the westbound right turn movement on E. Pleasant Hill Road.

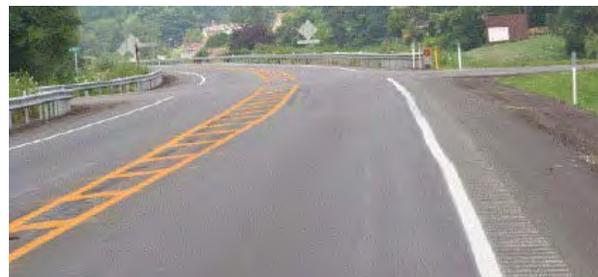
A painted median is proposed on E. Pleasant Hill Road to reduce operating speeds – including a 6 ft median and 10 ft lane widths adjacent to the curb/gutter section. FHWA documentation has found this to reduce fatal crashes on rural and urban roads by 20 percent. A total of 12 crashes (7 injury) crashes would be mitigated by this countermeasure.

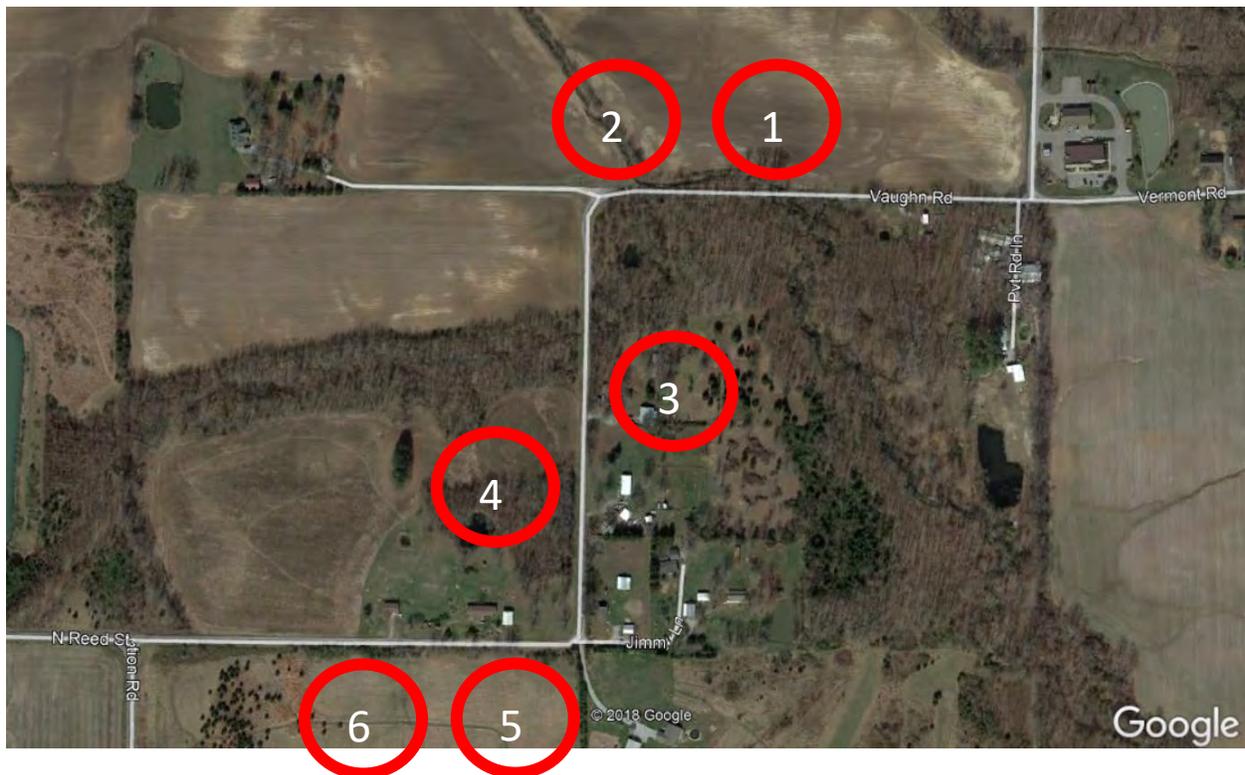
FIGURE 1: STUDY AREA

Vaughn Road is a roadway having an approximate width of 18 feet. Aggregate shoulders vary between 0 and 2 feet. The roadway does not have pavement markings. Existing curve warning signs include an advance turn sign (W1-1) with an advisory plaque of 20 MPH and a large arrow sign (W1-6) at the turns. **Photos 1-4** show the existing horizontal curves within the study area. The approximate location of each photo is numbered on **Figure 1**. The approximate distance from each curve is referenced for each photo.

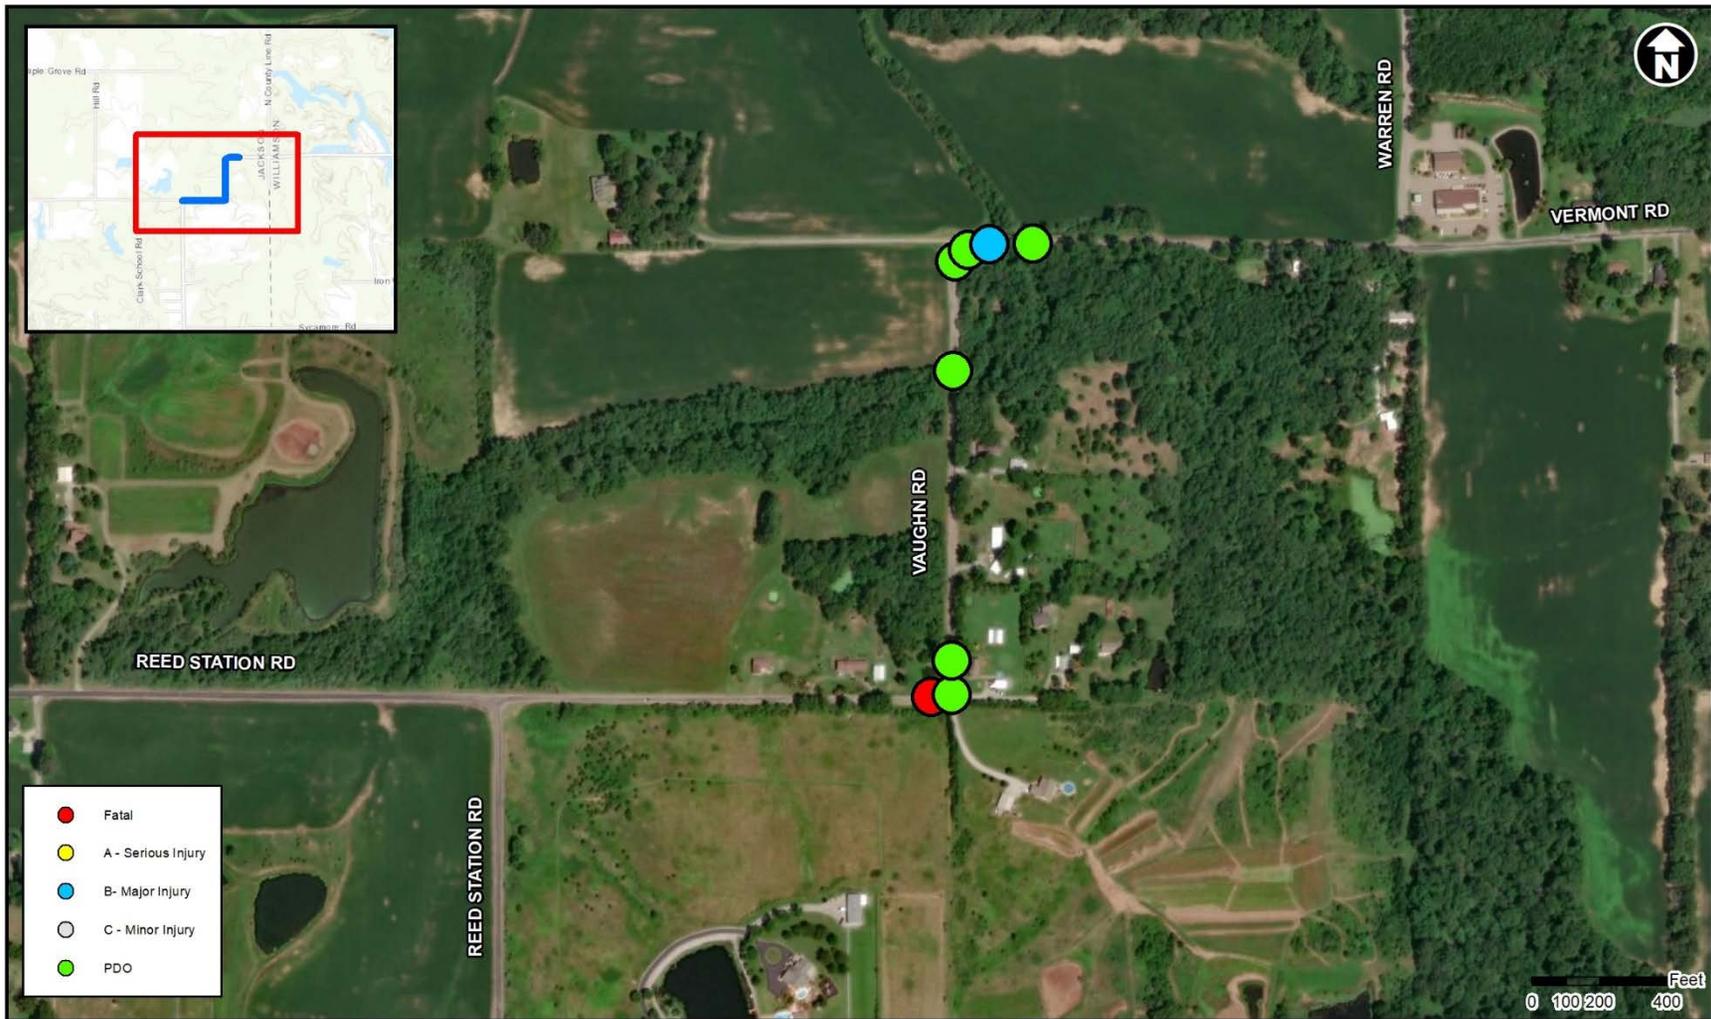
FIGURE 5: CRASH SEVERITY AND LOCATION MAP

Figure 5 shows the location and severity of crashes plotted on an aerial map of the study area.

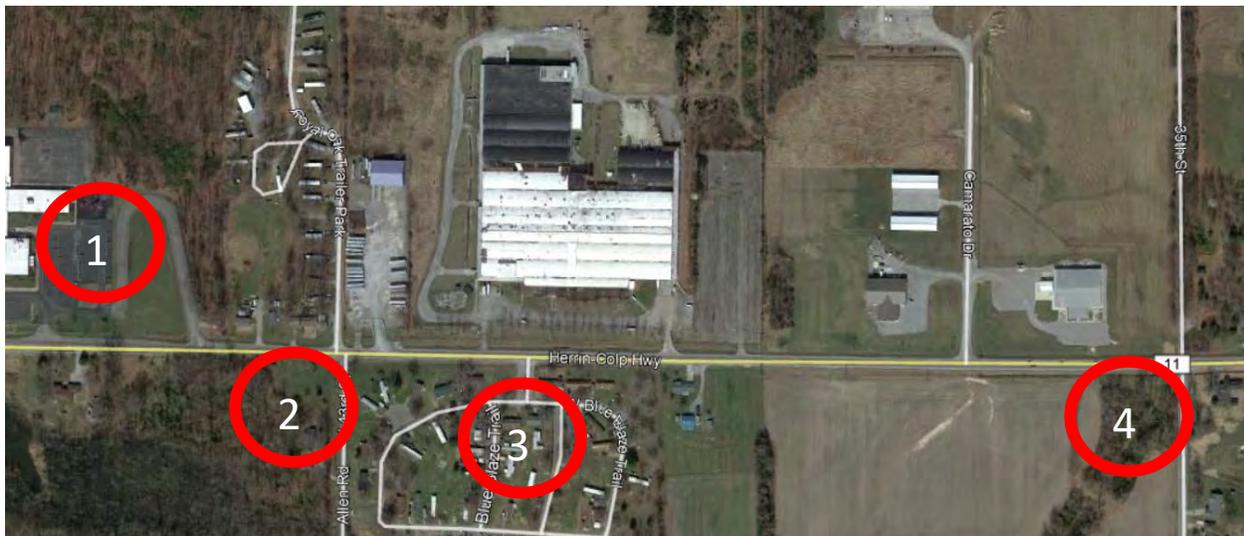
FIGURE 1: STUDY AREA

1. The east access to the Herrin Elementary School is located 500 feet west of the Allen Road/ N. 43rd Street intersection. The driveway to the school is signalized. See **Photo 1**.
2. The Allen Road/ N. 43rd Street intersection is unsignalized with the Allen Road approach stop controlled. The Royal Oak trailer park driveway is offset 25 feet west of Allen Road See **Figure 2**.
3. The driveway access to Blue Blaze residential community services up to 60 parcels. The access point is 50 feet wide and is located 600 ft east of the Allen Road/ N. 43rd Street intersection. See **Figure 3**.
4. The N. 35th Street intersection is unsignalized with the N. 35th Street approaches stop controlled.

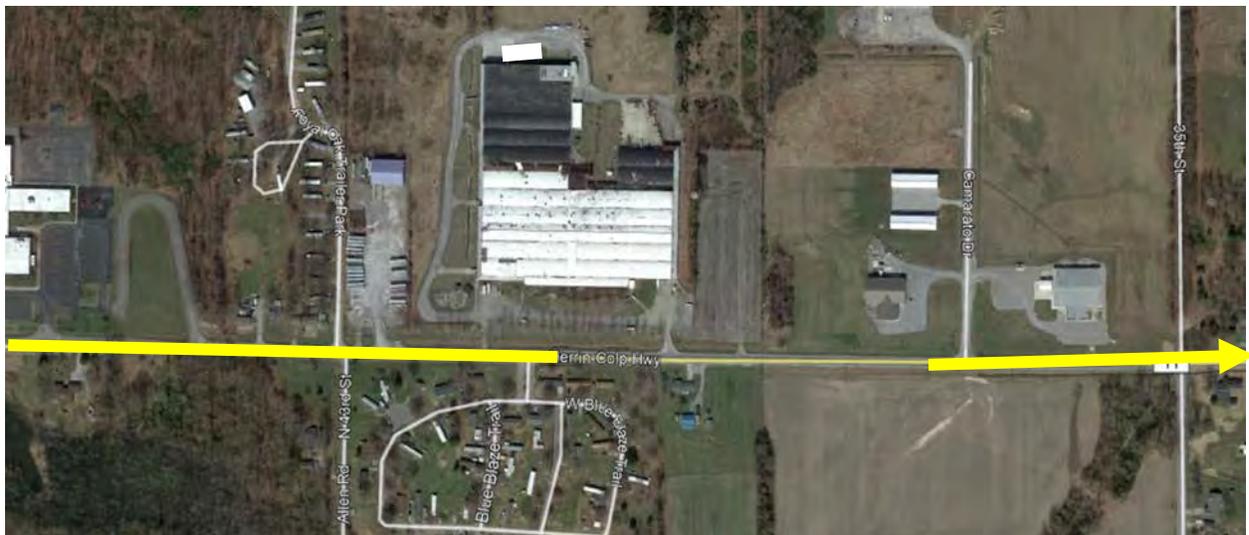
FIGURE 10: NO PASSING ZONE LOCATIONS

A passing zone would remain between Blue Blaze Trail and Camarato Drive (1,200 feet). The no passing zone would be located on segments of W. Herrin Road having the majority of crashes. **Figure 10** shows the minimum limits of the no-passing zone (yellow line).
