SOUTHERN ILLINOIS METROPOLITAN PLANNING ORGANIZATION (SIMPO) SAFETY STUDY

Williamson and Jackson Counties, Illinois

6.30.2021

CBB Job No. 39-20

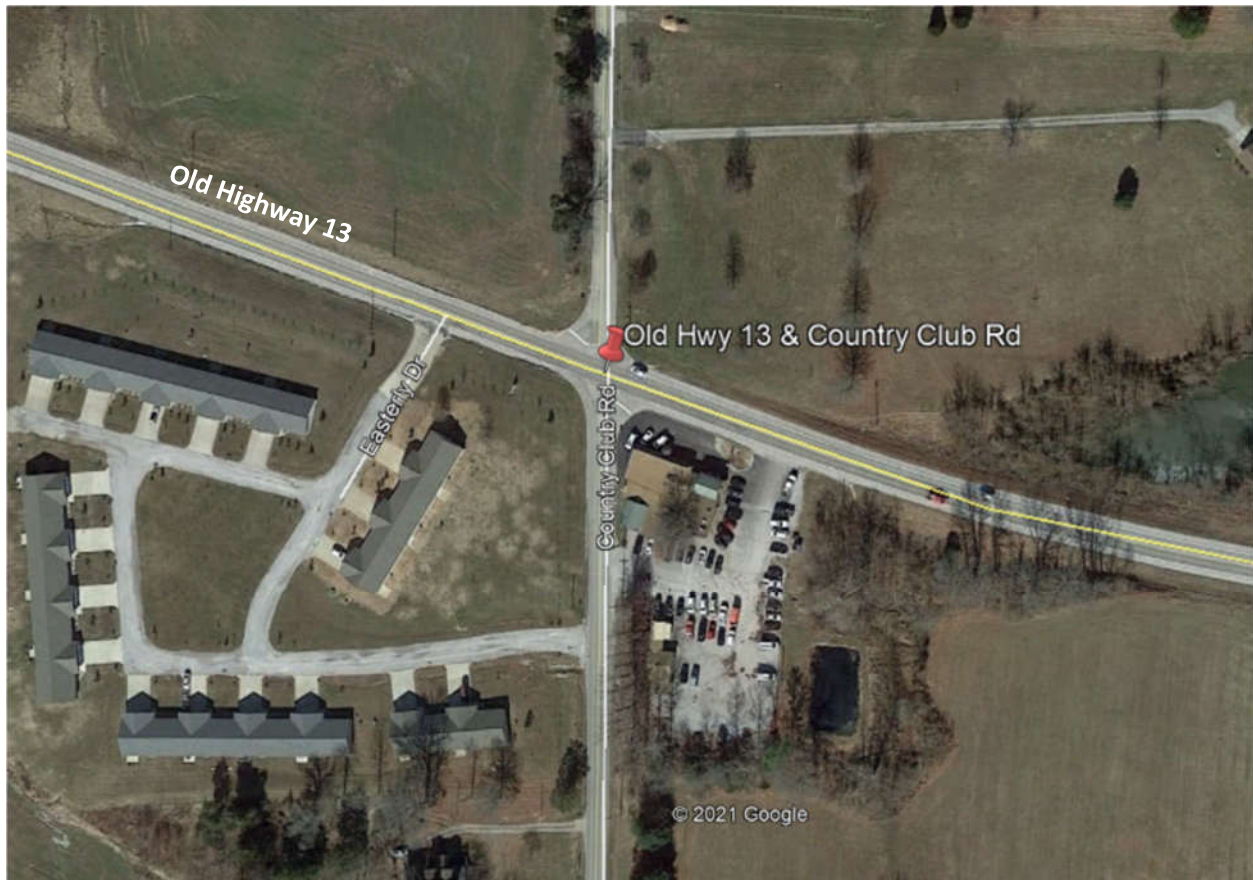
Figure 1: Study Area

The Old Highway 13 and Country Club Road intersection is located within the city of Murphysboro in Jackson County. The intersection is an unsignalized intersection with stop signs on Country Club Road. **Figure 1** shows the location of the intersection.

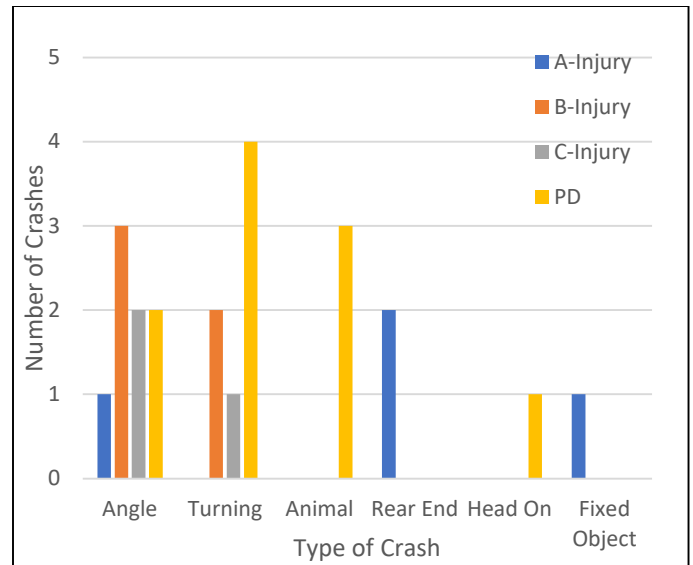
Figure 5: Frequency of Crashes by Type

Figure 5 shows the frequency of crashes by type. The majority of crashes are angle and turning crashes at 58 percent combined. 80 percent of the Angle/turning crashes involved **southbound** vehicles, many with **eastbound** vehicles.

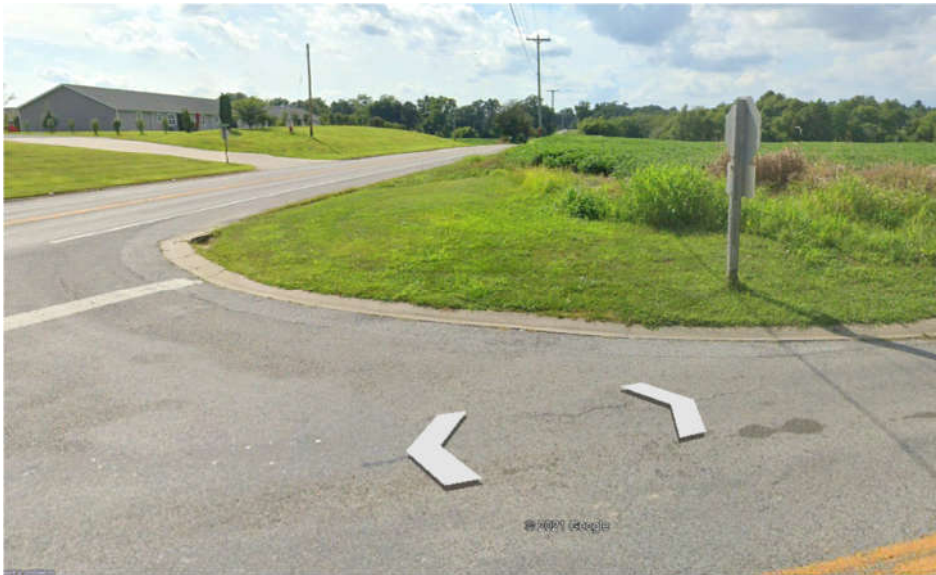
Figure 10: Sight Distance SB to EB (Google Earth - Northbound looking to the west)

Even though the sight distance meets IDOT policy, any potential improvements to sight distance by trimming/removing vegetation should be considered, see **Figure 10**.

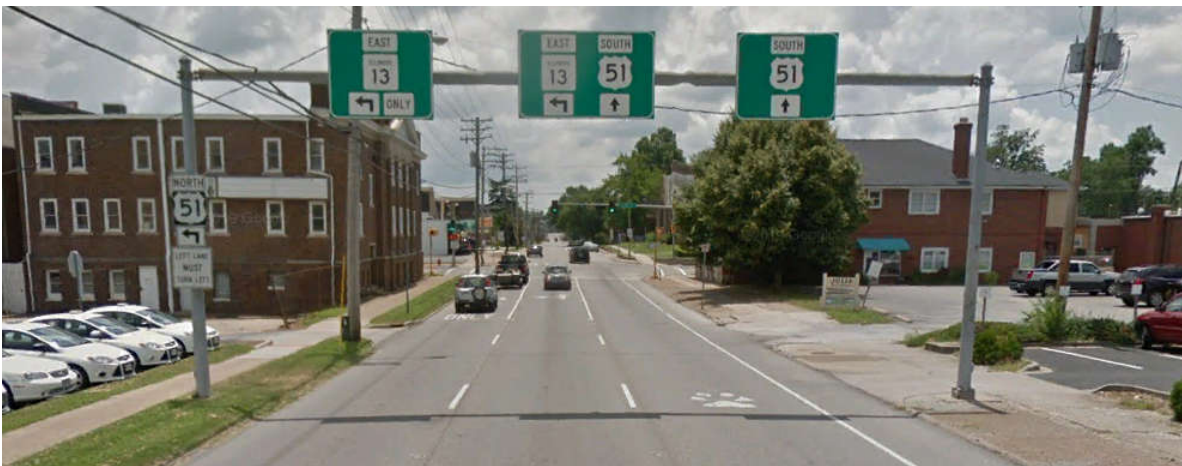
Figure 4: Southbound on University Avenue North of the Intersection (Looking South)

Since the building in the northwest corner restricts sight distance and to reduce turning and angle crashes, it is recommended to install a No Turn on Red (MUTCD R10-11) signs for the southbound approach so that vehicles do not strike pedestrians.

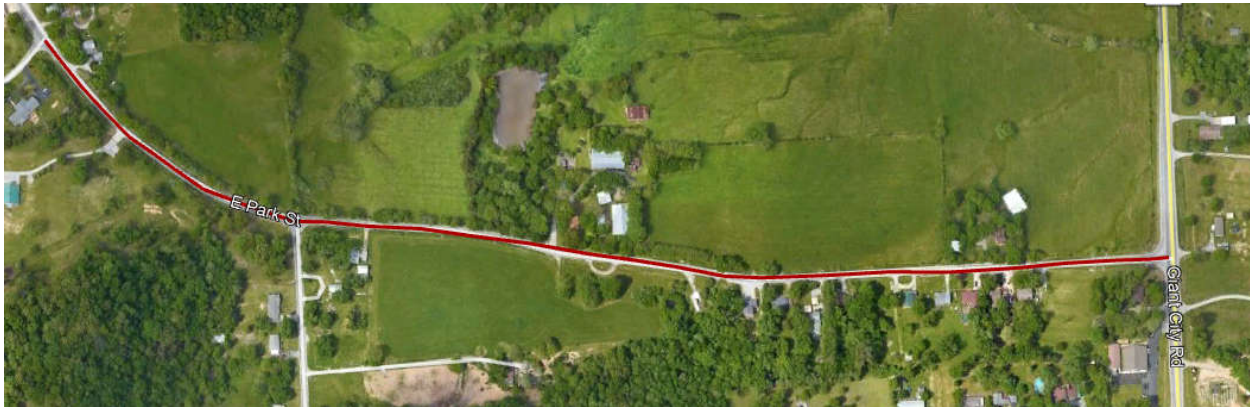
Figure 1: Study Area

The segment location is Park Street from Brush Hill Road to Giant City Road. The segment is about 0.71 miles long.

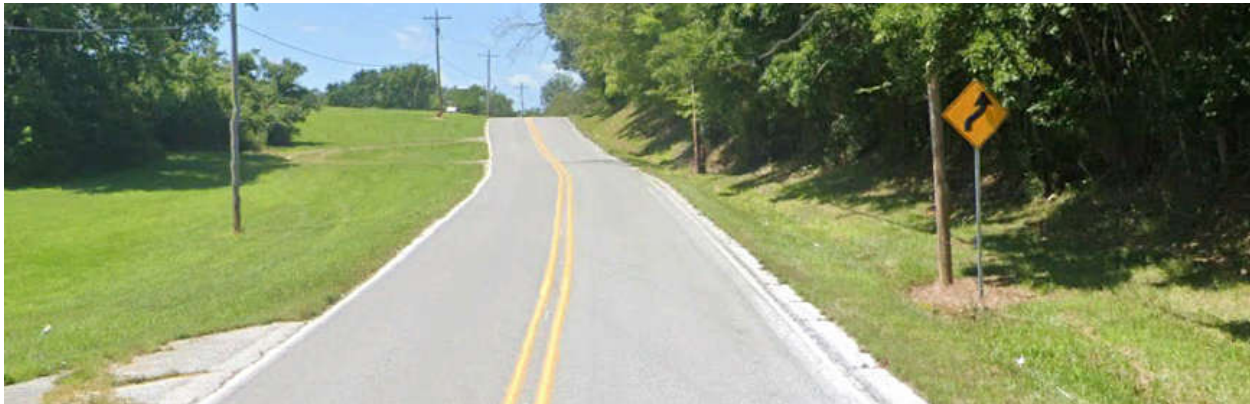
Figure 2: Reverse Curve

Park Street is located in Carbondale, in Jackson County. The corridor and connecting roads provide a connection to residential properties along the segment and in the area. The corridor is in an undeveloped area. The segment includes two lanes, one 11-foot lane in each direction. There is a speed limit of 30 miles per hour (mph). There are no sidewalks along the corridor or crosswalks in the study area. There is a reverse curve located to the east of the intersection of Park Street and Warren Road. The Carbondale Township Fire Department is just west of the study area.

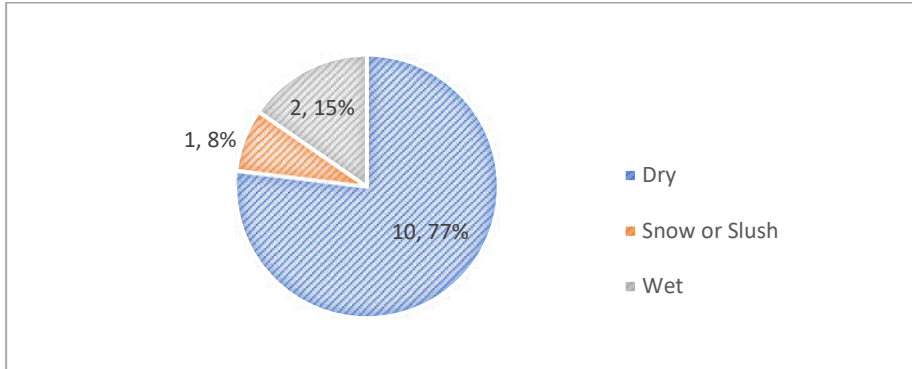
Figure 9: Frequency of Crashes by Road Condition

The frequency of weather crashes is shown in **Figure 9** below. The majority of crashes occurred on clear days (77%).

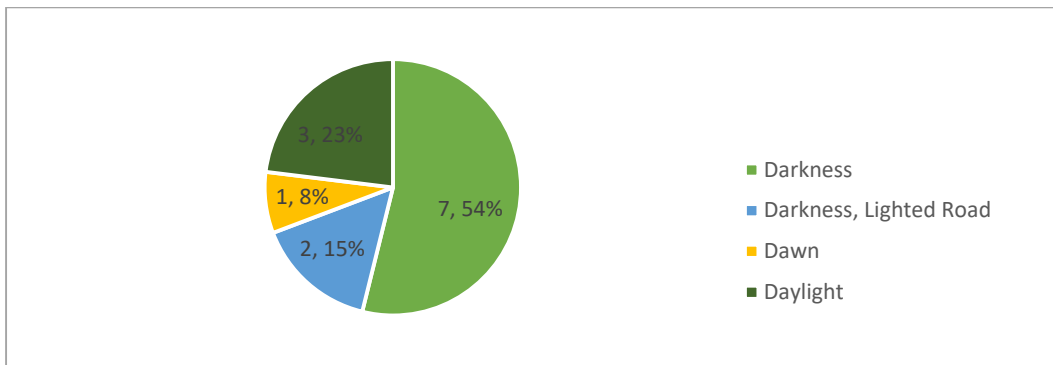
Figure 10: Frequency of Crashes by Lighting

The frequency of crashes related to lighting conditions is shown in **Figure 10** below. Only 31% of crashes occurred during the dawn/day, with **69% non-daylight crashes**.

Based on the crash data, it appears that motorists are not seeing the relatively minor curves and leaving the roadway. The dark conditions and the and the downhill grade (speed) also play a factor in the safety conditions.

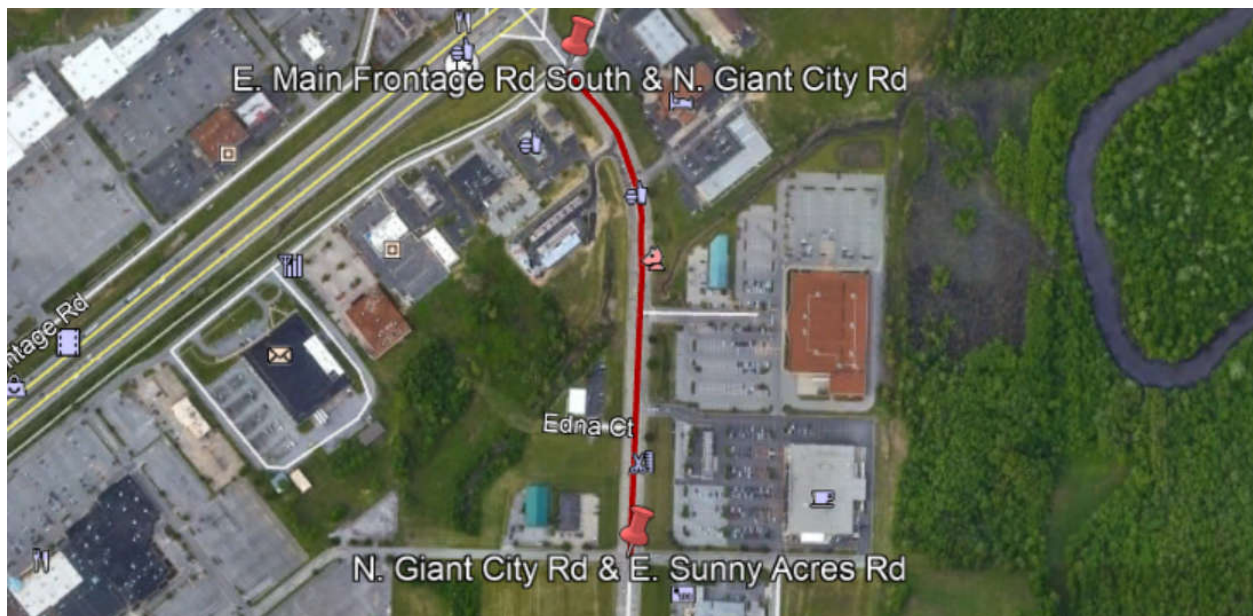
Figure 1: Study Area

The corridor includes the Giant City Road segment from East Main Frontage Road South to Sunny Acres Road, as well as the intersection of Giant City Road and East Main Frontage Road South and the intersection of Giant City Road and Sunny Acres Road. The segment is about .30 miles long. **Figure 1** shows the study area and includes the markers of the two intersections mentioned above.

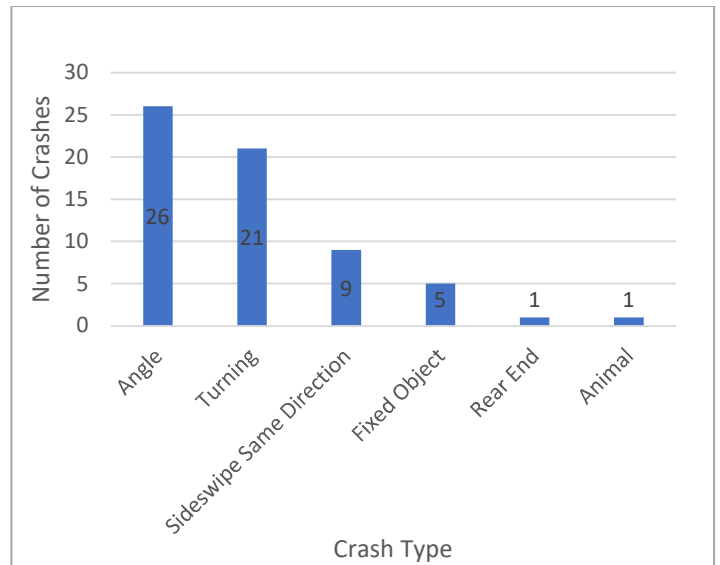
Figure 5: Frequency of Crashes by Type

The frequency of crashes by type is shown in **Figure 5**. The majority of crash types are angle and turning crashes. About 70 percent of crashes in the study corridor are at the intersections. Most of the intersection crashes are angle and turning crashes. The types of crashes on the segment are more diverse. The most common crash type on the segment are sideswipes at 42 percent.

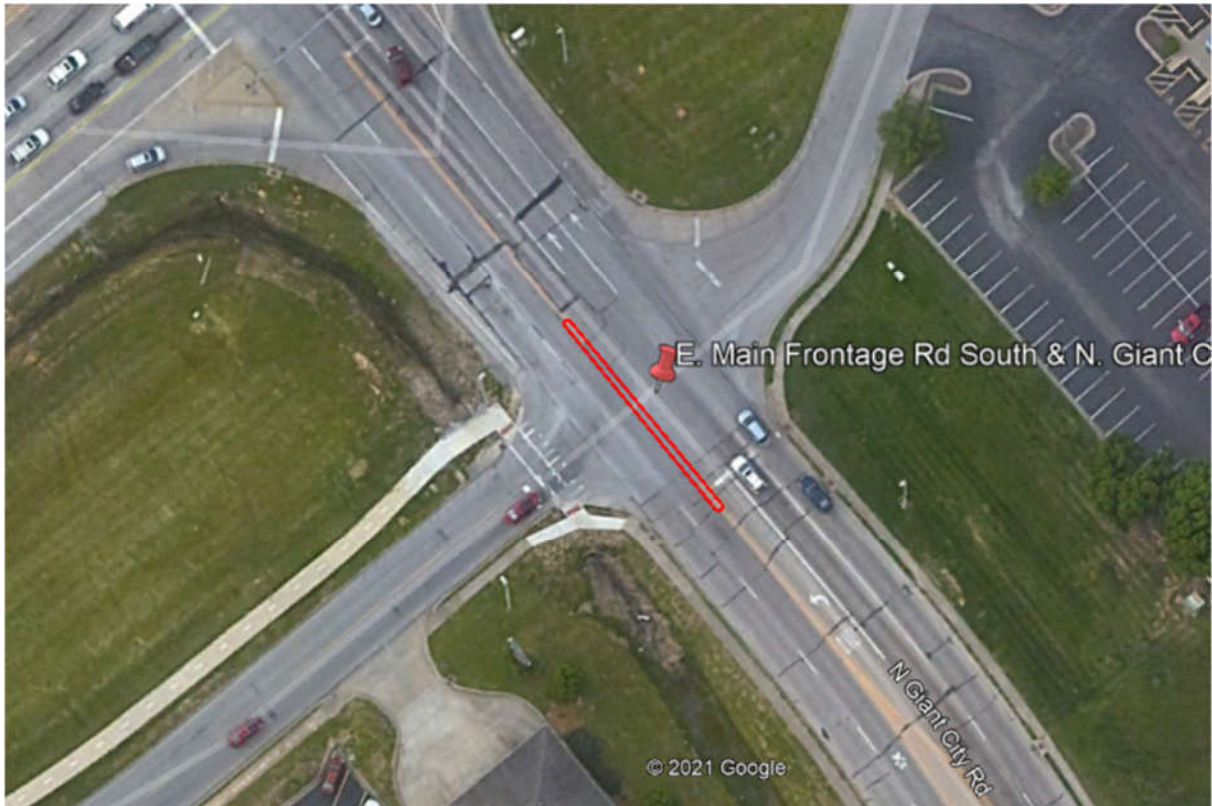
Figure 14: Example of Center Medians to restrict Frontage Access to Right-in/Right-out

Option 3 - Restrict all left-turns at the intersection with a center median on N. Giant City Road, see **Figure 14**.

In order to reduce the angle and turning crashes, restricting left-turns from the side-street is recommended. Should turns be restricted at this location, alternative access routes should be available. Restrictions could be accomplished in many different levels with varying degrees of effectiveness and safety benefits. For example, side-street turns could be restricted by signage, pavement markings, and/or enforcement, but the compliance maybe poor. One option is to restrict side street lefts at certain times of the day by posting signs and enforcing the signs. Typically, turns would be prohibited when there are long queues and delays, i.e. the peak hours.

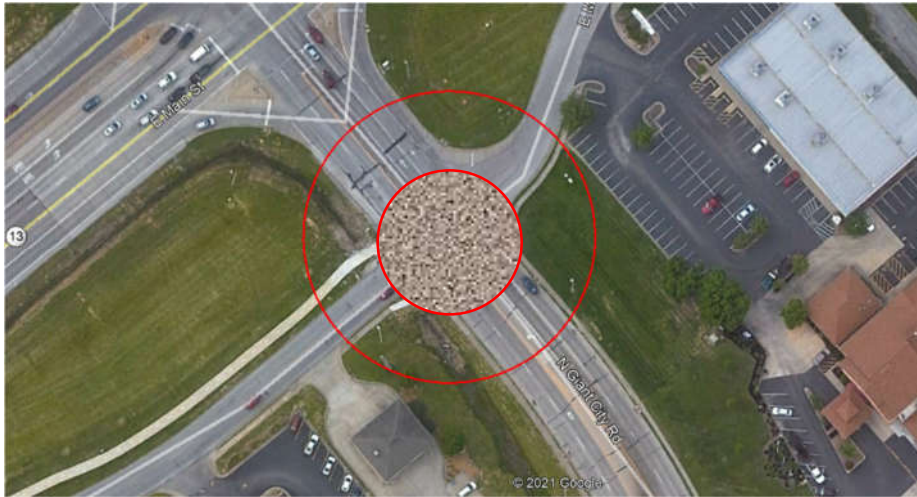
Figure 15: Potential Footprint of Roundabout (230' diameter)

On a larger scale, a roundabout could be evaluated at the intersection. Though, the roundabout requires a large footprint and will have operational impacts to the adjacent signal at IL 13 that would need to be addressed. FHWA recommends an inscribed circle diameter range of 105' to 250' for a two-lane roundabout.¹ **Figure 15** shows a 115 foot radius (230' diameter) circle, which represents the typical footprint that would likely be impacted by a two-lane roundabout.

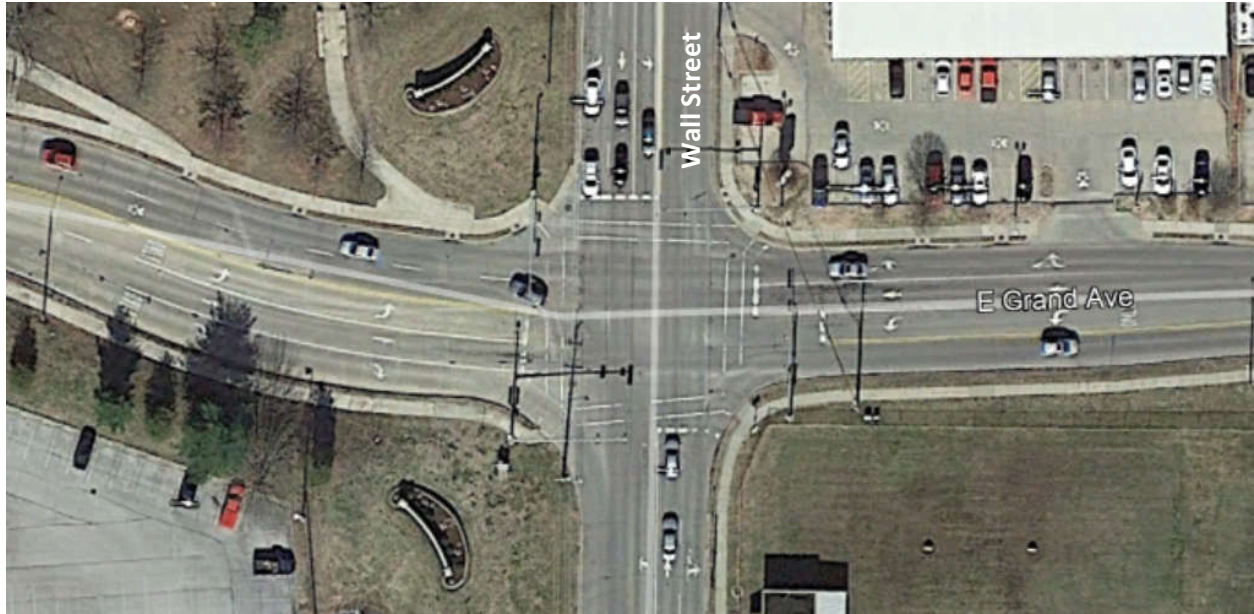
Figure 2: Intersection of Grand Avenue and South Wall Street

The intersection of Grand Avenue and South Wall Street is signalized and provides pedestrian accommodations including push buttons and crosswalks across all legs. The area surrounding this intersection includes student housing and a plaza with shops and restaurants, on the north. In the southwest corner of the intersection, there is a parking lot for the university.

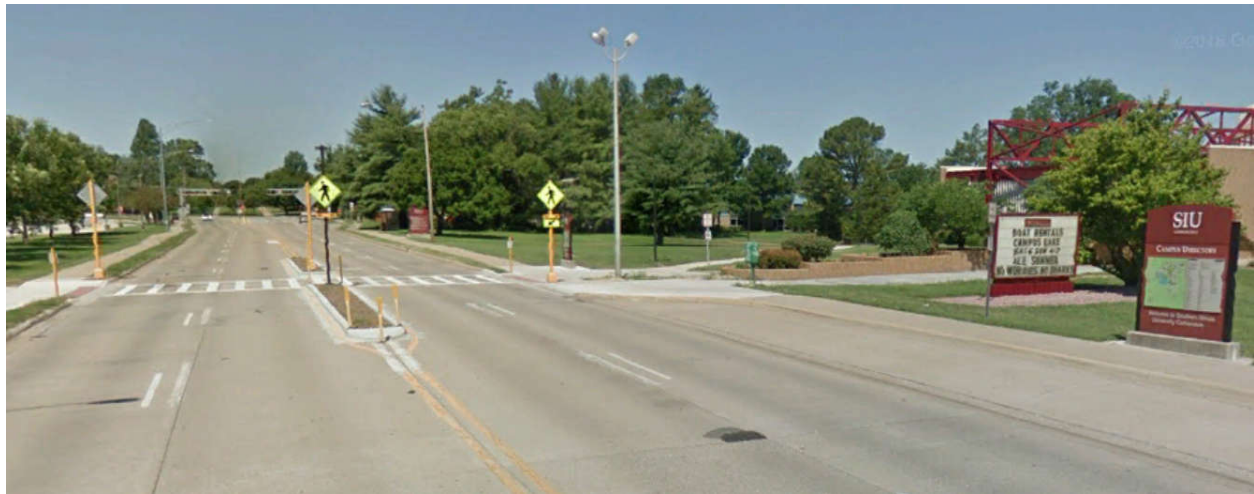
Figure 3: RRFB to SIU Student Recreation Center

Several of the buildings along the corridor are apartments and housing for college students attending the university. Pedestrians can use the sidewalks that are along the corridor and have access to crossing the roadway at two different locations. The two locations provide marked pedestrian facilities to cross Grand Avenue. One crossing is at the intersection of Grand Avenue and South Wall Street, in **Figure 2**, and the other crossing is at a rectangle rapid flashing beacon (RRFB), in **Figure 3**, located about 550 feet east of the intersection of Grand Avenue and Washington Street and in front of the Southern Illinois University (SIU) Student Recreation Center.

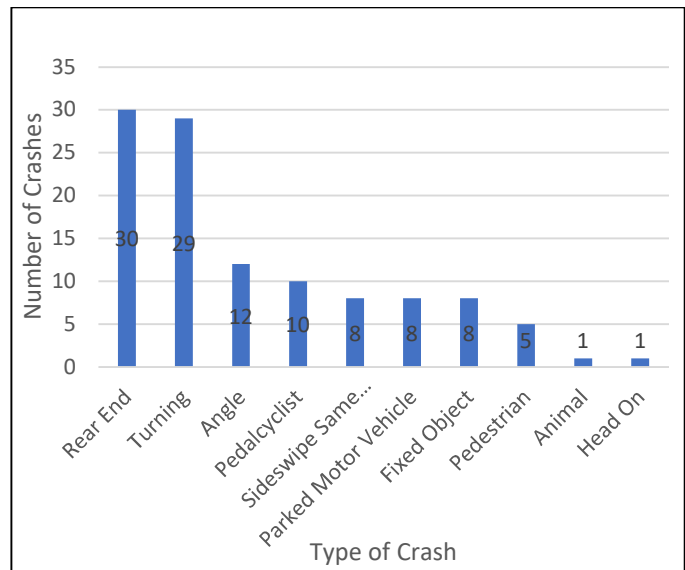
Figure 6: Frequency of Crashes by Type

Figure 6 shows the frequency of crashes by type. The majority of crashes are rear ends and turning crashes at 53 percent combined. Half the crashes are at the intersections in the study area and half are along the corridor. There are 10 pedalcyclist crashes and 5 pedestrian crashes. All bicycle and pedestrian crashes resulted in A-Injury, B-Injury, or C-Injury crashes. As mentioned above, the SIU Student Recreation Center and student housing for the university are located along the corridor. This land use adds more pedestrian and bicyclist movements along the corridor.

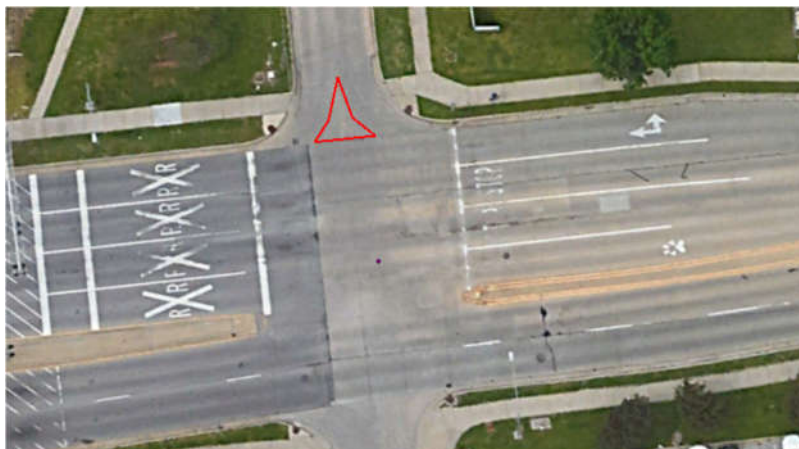
Figure 14: Example of “Porkchop Island” on Washington Avenue

Restricting through and left-turns for the southbound approach with signing, pavement markings, and/or enforcement would also help mitigate turning and angle crashes. A “porkchop island” on the southbound approach could be used to physically restrict through and left-turning vehicles, see **Figure 14**.

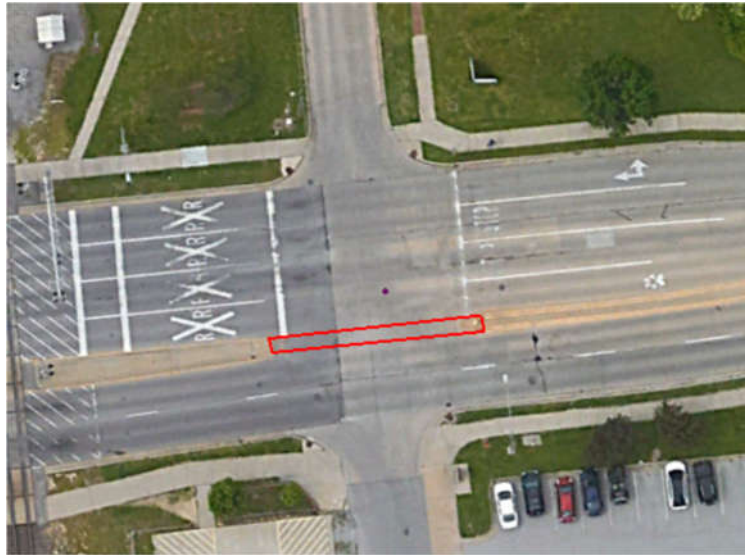
Figure 15: Example of Median to restrict Washington to Right-in/Right-out

Another option would be to physically restrict all left-turns with a raised center median on N. Grand Avenue, see **Figure 15**. In this case, alternative routes for left-turns would need to be provided.

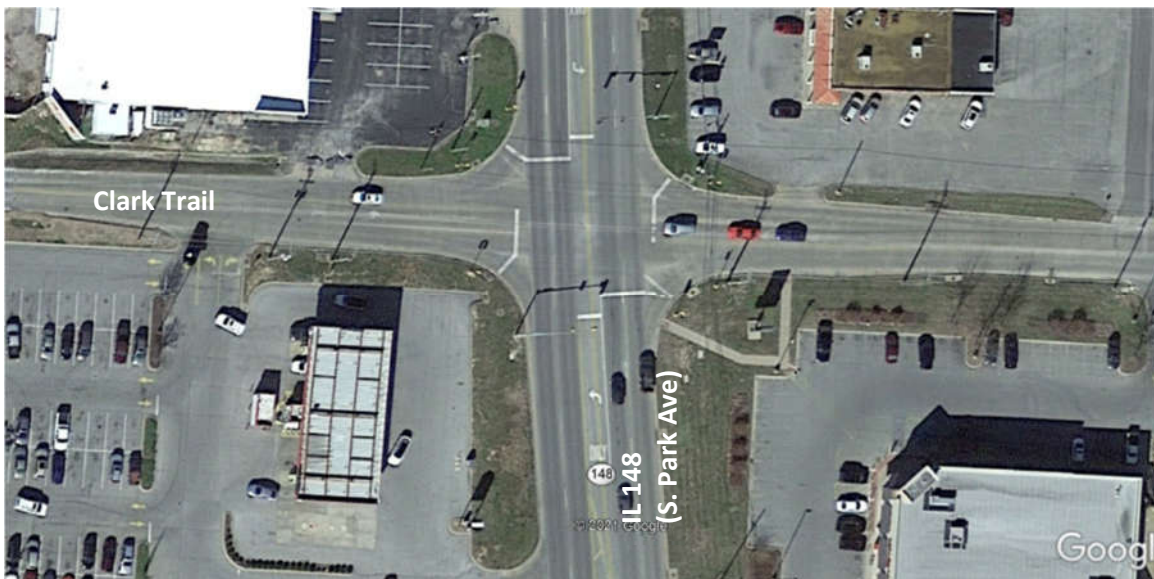
Figure 2: Intersection of IL 148 and Clark Trail (Plan View)

At the signalized intersection of Illinois Route 148 and Clark Trail, the center turn lane is striped as a separate left-turn lane. Both the eastbound and westbound approaches of Clark Trail have a separate left-turn lane and a shared through/right-turn lane. The signalized intersection has a combination of overhead and ground mounted signals, as seen in **Figure 2**. The north-south left-turns operate under a protected plus permissive phasing, while the east-west approaches operate under a common (permissive) phase.

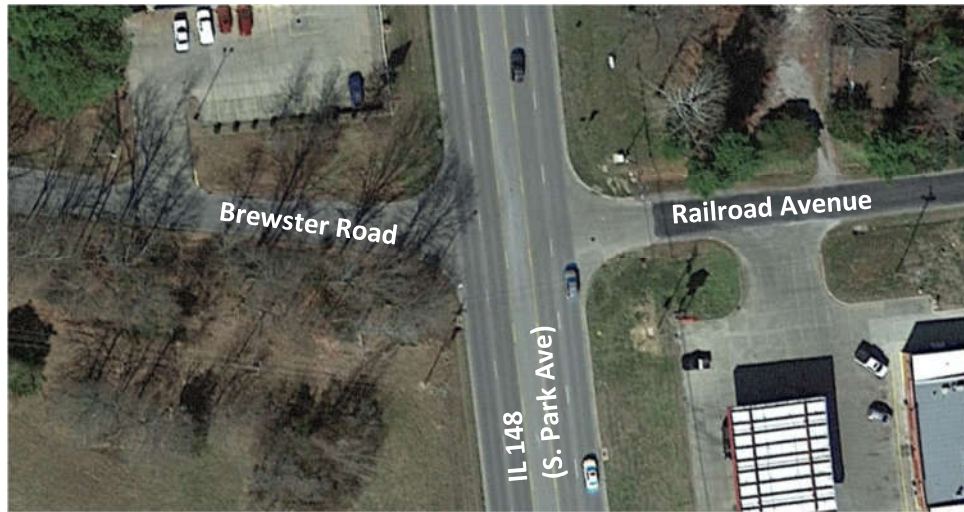
Figure 3: Intersection of Illinois 148 and Brewster Road (Plan View)

The intersection of Illinois 148 and Brewster Road is unsignalized with vehicles on Brewster Road required to stop at Illinois 148, see **Figure 3**. Brewster Road is a two-lane road that is about 20 feet wide and has no pavement markings. A concrete apron with curb and gutter is provided at the intersection with Illinois 148. The sight distance to the south may be less than optimal due to an earth berm and signs along the west side of the road, see **Figure 4**. Intersection sight distance for left-turns on the side street is 625 feet assuming 50 mph design speed and a five-lane cross section.

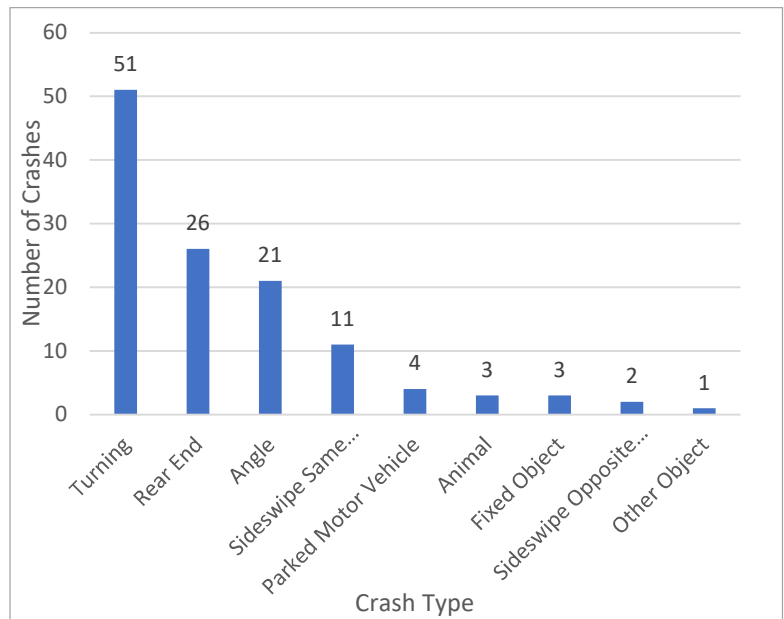
Figure 6: Frequency of Crashes by Type

The frequency of crashes by type is displayed in **Figure 6**. It shows the majority of crashes are turning crashes at 42 percent. Three out of the six A-injury crashes are turning crashes. Rear end and angle crashes make up another 39 percent of crashes and include the other three A-injury crashes on the corridor.

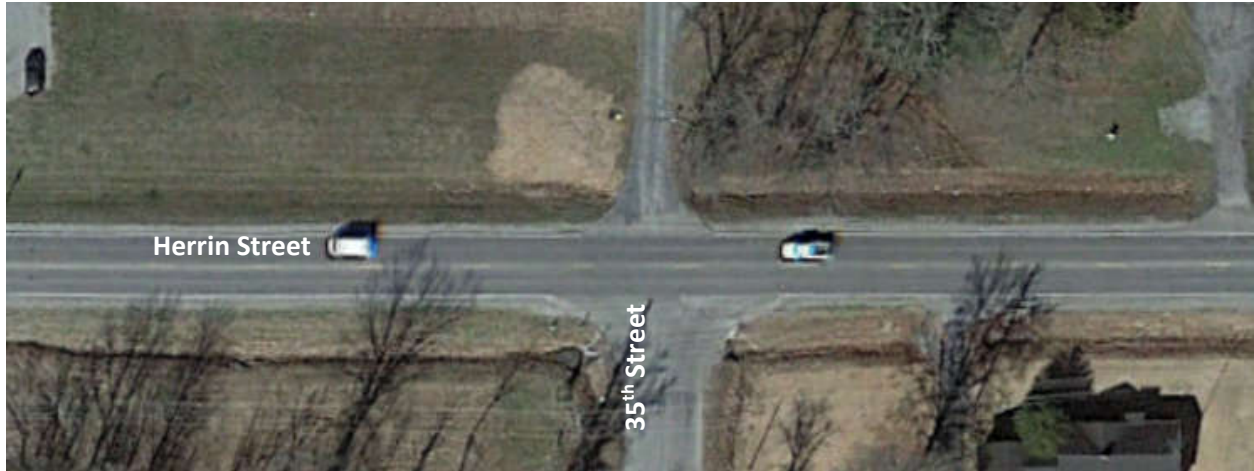
Figure 2: Intersection of Herrin Street and 35th Street (Aerial View)

Herrin Street is located in Herrin, Illinois. The corridor is in a more rural area providing access to some residential properties and Herrin Elementary shown in **Figure 3**. The segment includes several public street intersections that are side-street stop-controlled as well as one signalized intersection that serves Herrin Elementary. Herrin Street is two lanes, one in each direction. Separate westbound right-turn lanes are provided at the signalized intersection for the school as well as the center school entrance (bus and staff entrance during arrival and dismissal). A separate eastbound left-turn is provided at the middle entrance and the taper extends through the west entrance. West of the school, Herrin Street includes a two-foot paved shoulder and rumbles on both sides of the road. The study corridor (from 35th street to Herrin Elementary) has some gravel shoulders along the road with ditch drainage. There are no sidewalks or crosswalks along the corridor. The corridor has a posted speed limit of 45 miles per hour (mph) and also includes a School Zone Ahead sign assembly with flashing beacon for eastbound traffic, west of the school.

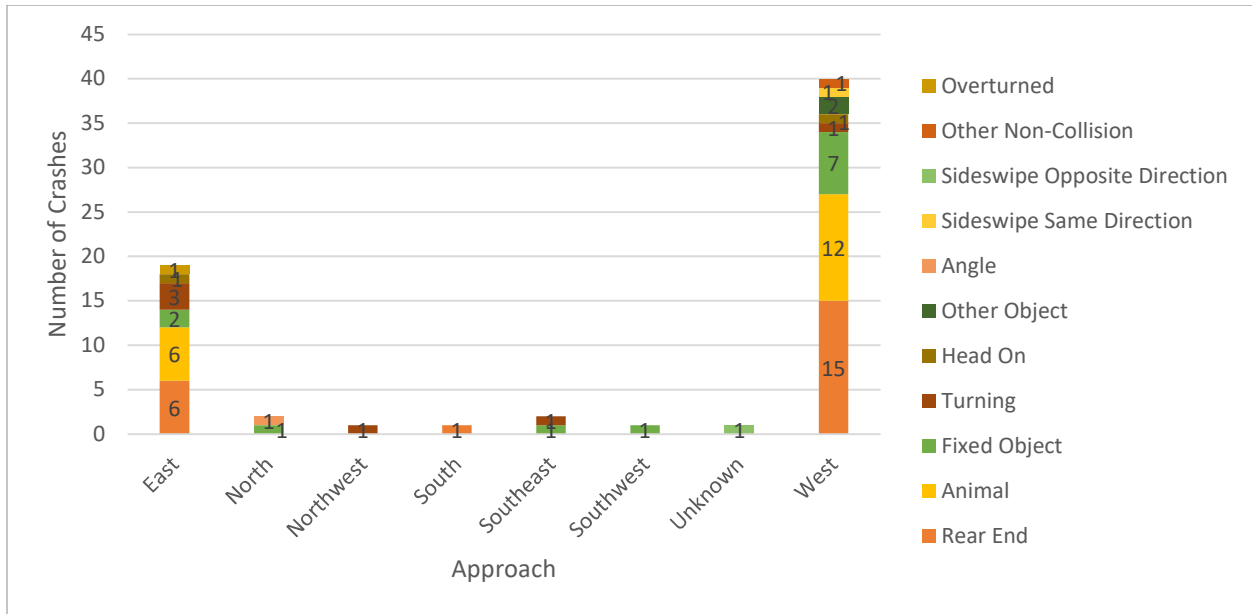
Figure 7: Frequency of Crashes by Direction and Crash Type

In **Figure 7** the frequency of crashes by direction and crash type is shown. Most crashes are traveling westbound and some eastbound. A majority of fixed object crashes are drivers traveling westbound. One cause for this, is the ditch for drainage on the side of the roadway.

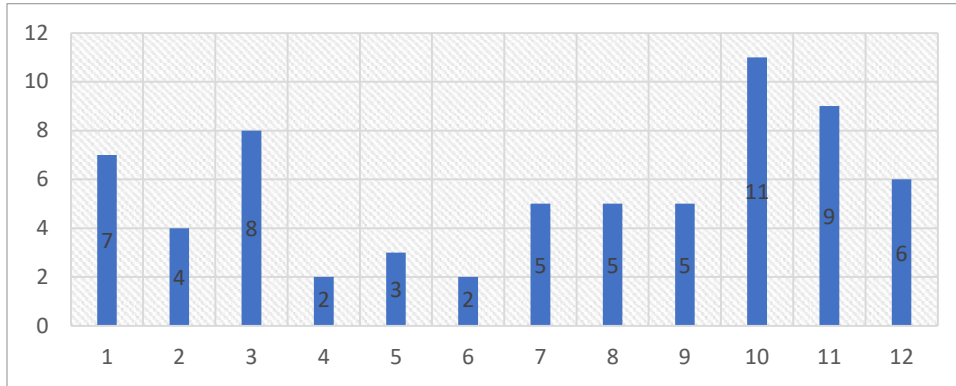
Figure 9: Frequency of Crashes by Month

The frequency of crashes by month is shown in **Figure 9**. The months of October, November, and March are the peak months. The animal crashes are heavy in these peak months.

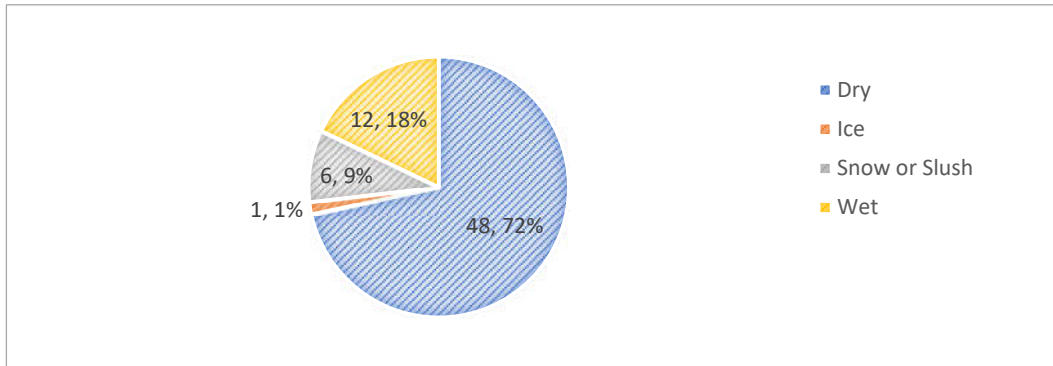
Figure 10: Frequency of Crashes by Weather

The weather condition is shown in **Figure 10**. The majority of crashes occurred on clear days (72%). It should be noted that non-dry conditions were a contributing factor in nearly half of the fixed object, angle/turning crashes, and about 30 percent of the rear ends.

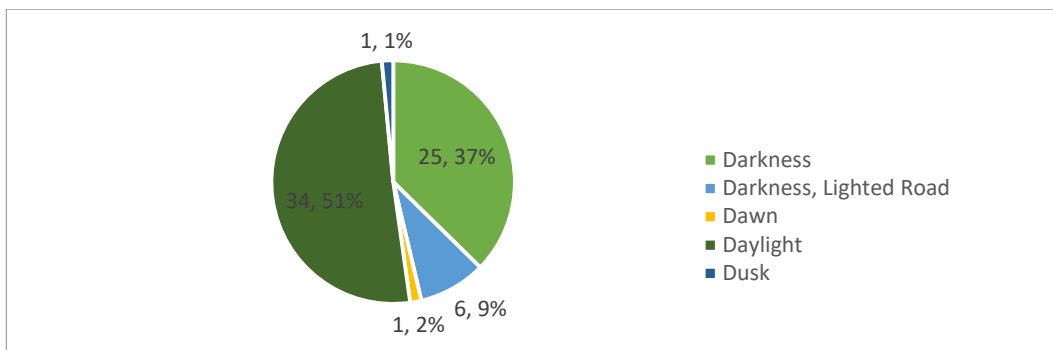
Figure 11: Frequency of Crashes by Lighting

The lighting condition is shown in **Figure 11**. Approximately half of crashes occurred during daylight hours (51%), while about 40 percent occurred in the dark or during the dusk/dawn hours and 9 percent in the dark on a lighted road. A large portion of the dark crashes involved animals.

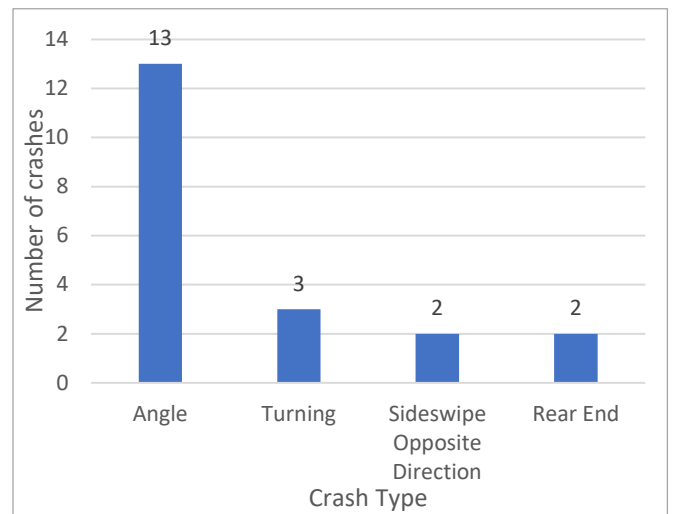
Figure 5: Frequency of Crashes by Type

Figure 5 displays the frequency of crashes by type. About 65 percent of crashes are angle crashes. The other 35 percent are turning crashes, read ends, and sideswipe crashes.

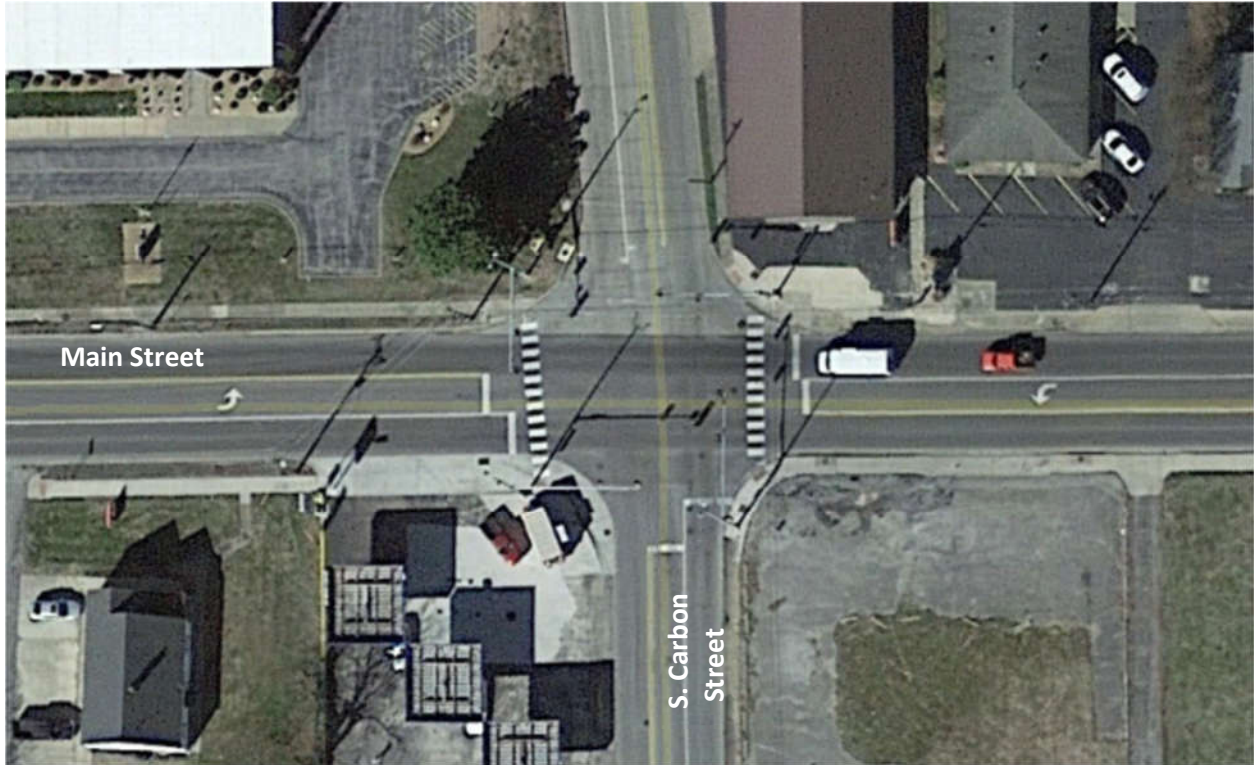
Figure 2: Intersection of South Carbon Street and West Main Street

An aerial view of the intersection is shown in the plan view, see **Figure 2**. The adjacent land uses are commercial and residential properties and the intersection is controlled by a traffic signal. South Carbon Street is a two-lane road that widens out at the intersection with Main Street to provide northbound and southbound left-turn lanes. Main Street generally consists of a three-lane cross section (one-lane in each direction plus a two-way left-turn lane). At the signalized intersection with South Carbon Street, Main Street is striped as a left-turn lane and shared through/right-turn lane.

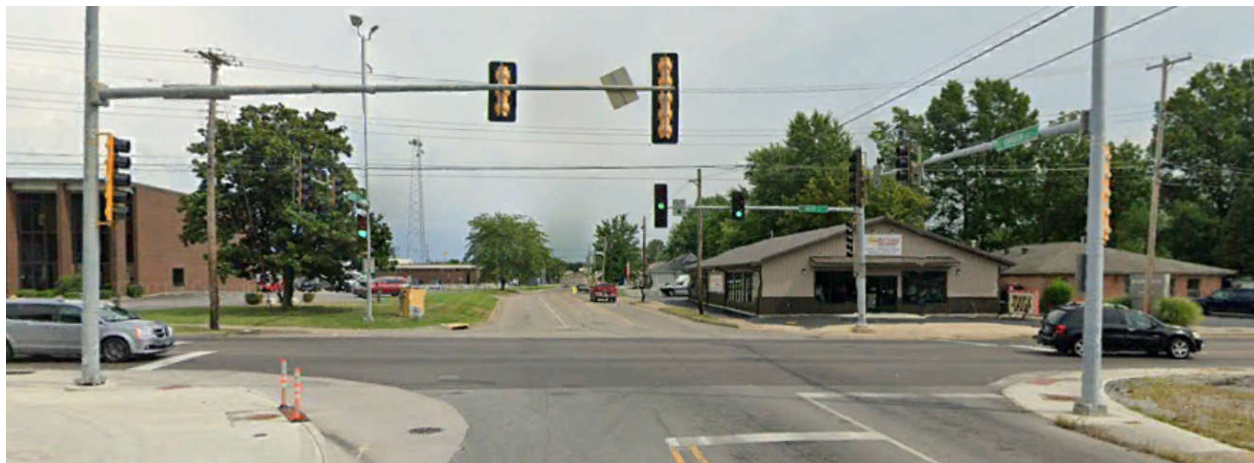
Figure 3: Intersection of South Carbon Street and West Main Street (looking Northbound from South Carbon Street)

Both South Carbon Street and Main Street have a posted speed limit of 30 miles per hour (mph). Approximately 280 feet east of the intersection, there is a 20-mph school zone when children are present along Main Street for Marion Junior High School. There are sidewalks along both South Carbon Street and Main Street. At the intersection, there are marked crosswalks on the east and west side of the intersection. It should be noted that radius improvements were made to the southwest quadrant of the intersection around 2018. **Figure 3** shows the street view of the intersection.

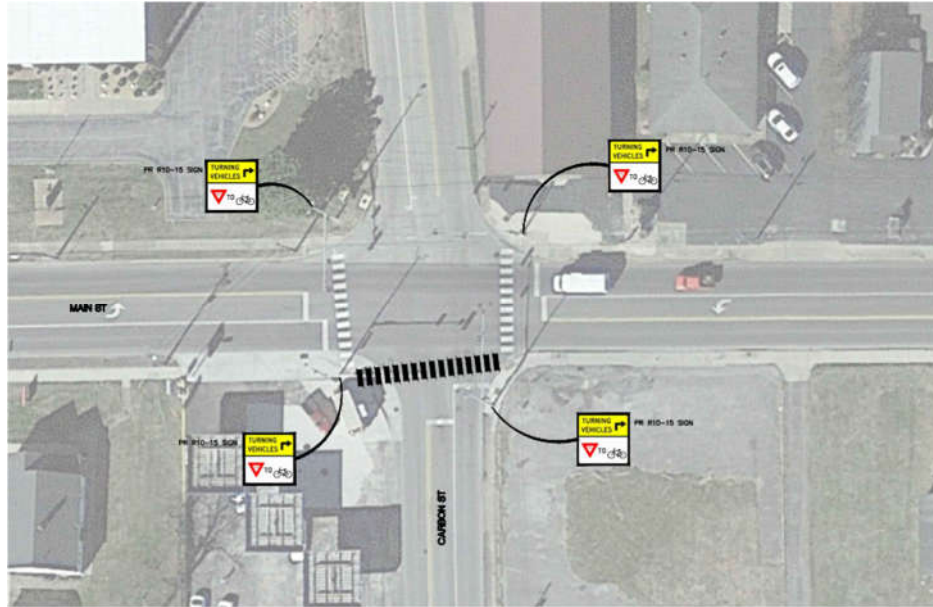
Figure 11: “Turning Vehicles Yield to Bicycles” signs on signals

Due to the number of observed bike crashes, it is recommended that the City consider evaluating the Main Street corridor for bike facilities, which is beyond the scope of this study. Based on the crash data, the bike crashes at the intersection were westbound bikers on the south side of the intersection getting struck by northbound vehicles. In order to bring attention to pedestrians/bikes possibly at the corner, “Turning Vehicles Yield to pedestrians/bicycles” (MUTCD R10-15) signs could be installed on the mast arms to remind motorists to be on the lookout for pedestrians/bikes, see **Figure 11**.

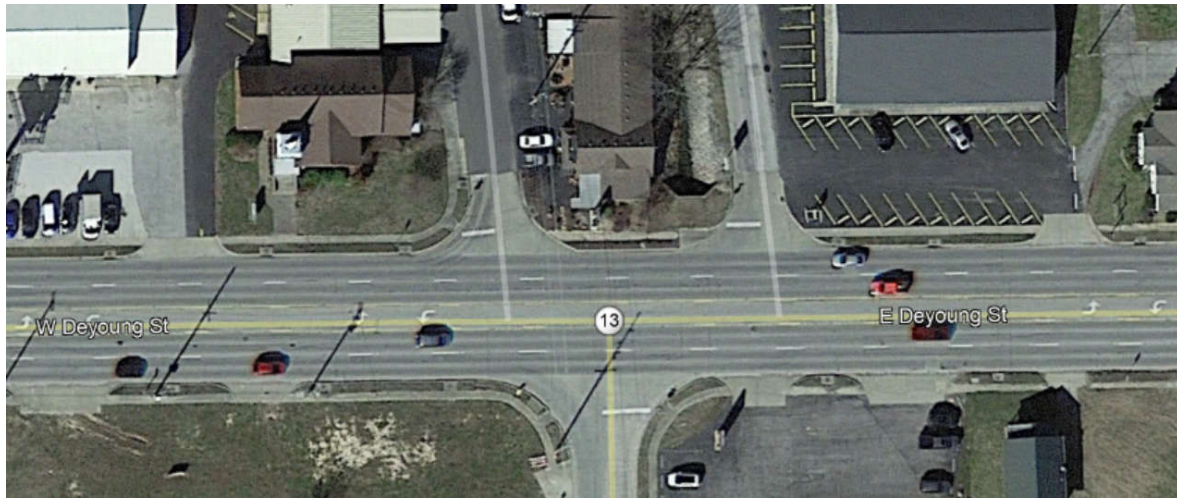
Figure 2: Intersection of Deyoung Street and Market Street (Plan View)

Figure 2 and **Figure 3** includes a plan view and street view of the intersection. The intersection is located in a developed, residential area. The intersection is at a right-angle alignment as shown in the plan view. Market Street has one lane in each direction and has a speed limit of 25 miles per hour (mph). Deyoung Street has two 11-foot lanes in each direction and a 12-foot center lane and has a speed limit of 35 mph. There are sidewalks along both roads but no crosswalks at the intersection. The northbound approach is flared and has large radii.

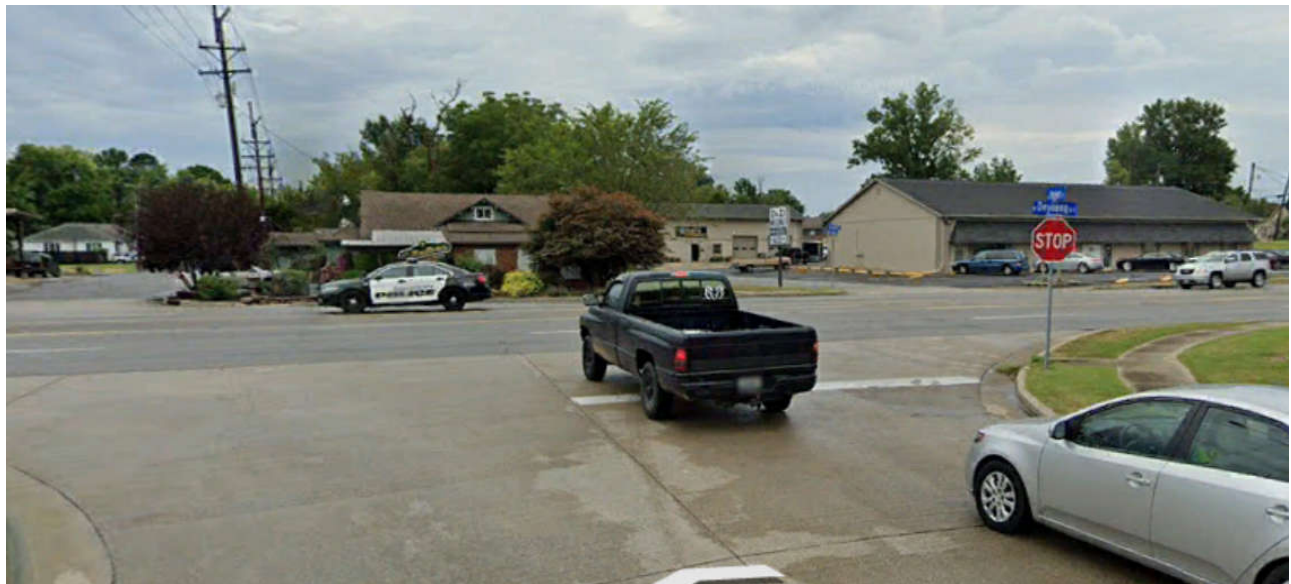
Figure 3: Intersection of Deyoung Street and Market Street (Street View)

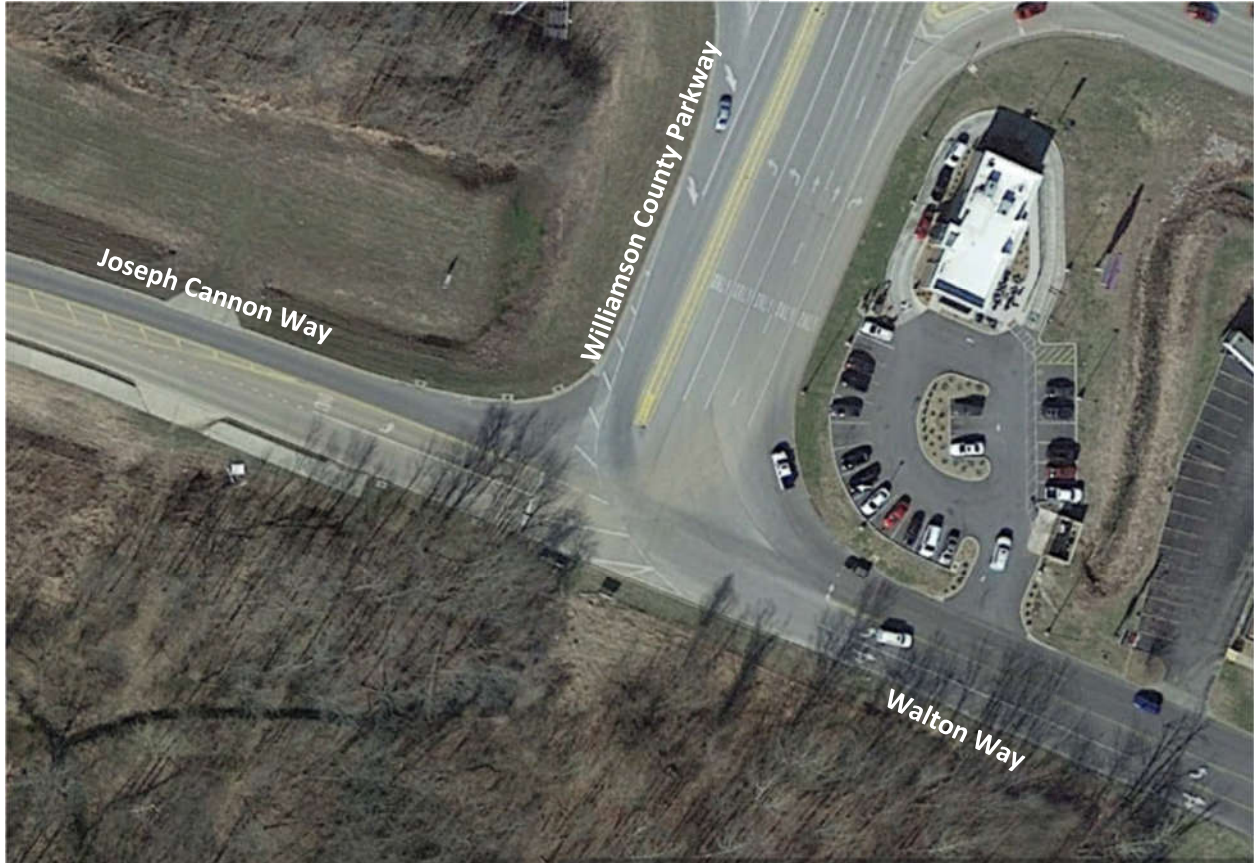
Pavement markings still remain that guide motorists to the east when there was originally no west leg to the intersection. There are no sidewalks or crosswalks at the intersection.

Figure 2: The Intersection of Williamson County Parkway and Walton Way (Plan View)
