SOUTHERN ILLINOIS METROPOLITAN PLANNING ORGANIZATION (SIMPO) SAFETY STUDY

Williamson and Jackson Counties, Illinois

6.30.2021

CBB Job No. 39-20

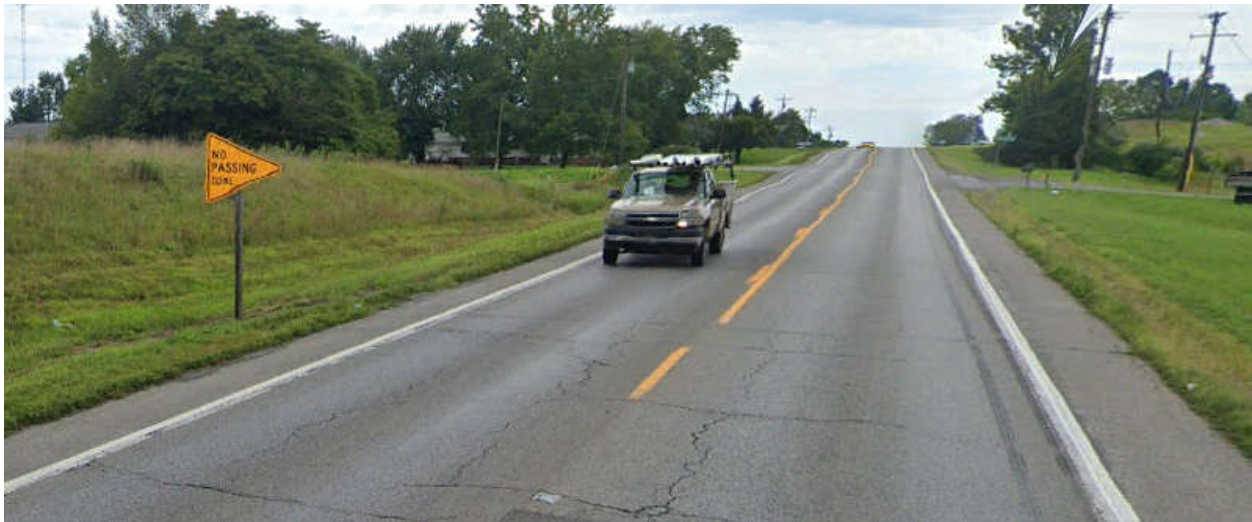
Figure 2: No Passing Zone

Illinois 37 is located in Williamson County, Illinois. The corridor is in a mostly rural area and provides a parallel route to Interstate 57 between Marion and Johnston City. It also provides access to some residential properties and businesses along the corridor. The segment has one lane in each direction (generally 11 to 12-foot lanes in each direction) and paved shoulders on both sides (generally 4 to 8-foot wide). White edgelines and yellow skip pavement markings are provided. There are three no passing zones in the study area. One no passing zone extends from Longstreet Road to approximately 0.1 mile south of the intersection and another no passing zone starts approximately 0.1 mile north of Longstreet Road for about 0.1 mile further north. The final no passing zone starts about 0.05 mile south of Cedar Grove Road and extends approximately 0.08 mile north of Cedar Grove Road. **Figure 2** shows the no passing zone near Cedar Grove Road. There are no sidewalks or crosswalks, and the speed limit is 45 miles per hour (mph).

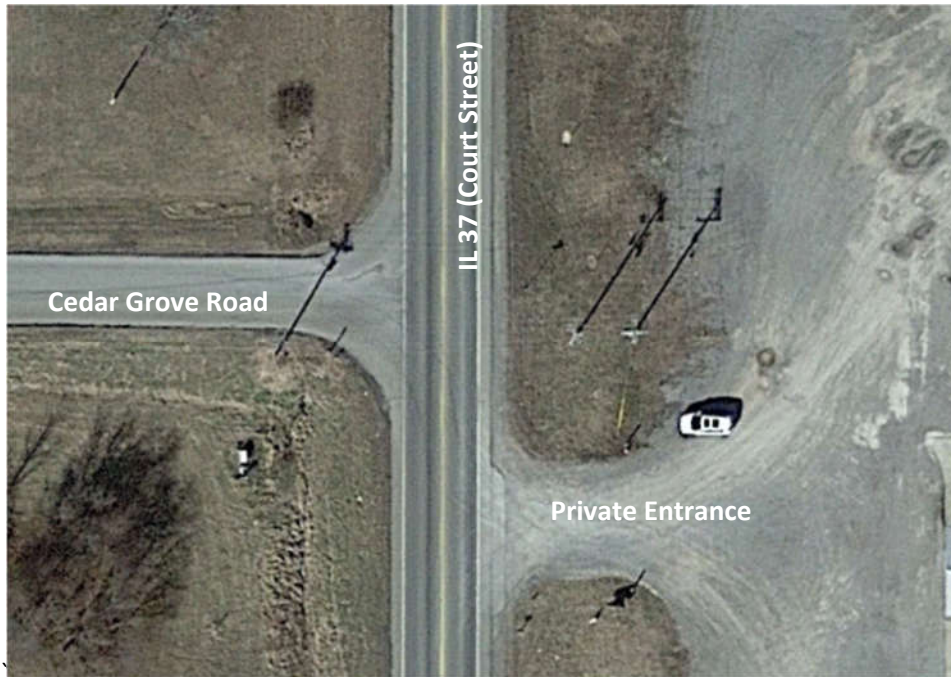
Both intersections of Longstreet Road and Cedar Grove Road are required to stop at the intersection with Illinois 37. The intersection of Illinois 37 and Cedar Grove Road is a three-legged intersection, but there is a private drive offset a short distance to the south (approximately 70 feet). Cedar Grove Road provides access to mainly residential land uses west of Illinois 37. The intersection of Illinois 37 and Cedar Grove Road is shown in **Figure 3**. No pavement markings are provided on Cedar Grove Road.

Figure 3: The Intersection of Illinois 37 and Cedar Grove Road

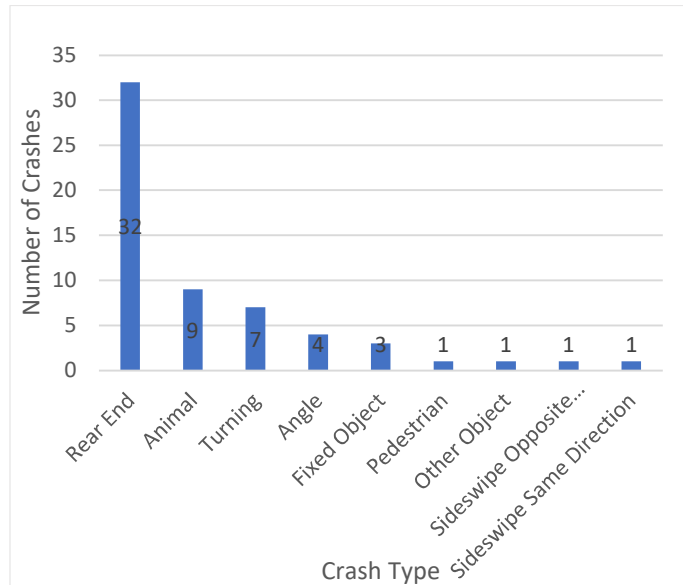
Figure 6: Frequency of Crashes by Type

Figure 6 shows the frequency of crashes by type. The majority of crashes are rear end crashes, of which about 56 percent of the rear end crashes are property damage only. The other 43 percent of crashes are a combination of A-Injury (1), B-Injury (10), and C-Injury (3) crashes. The second most frequent crash type is animal crashes (9), which were all deer and property damage only.

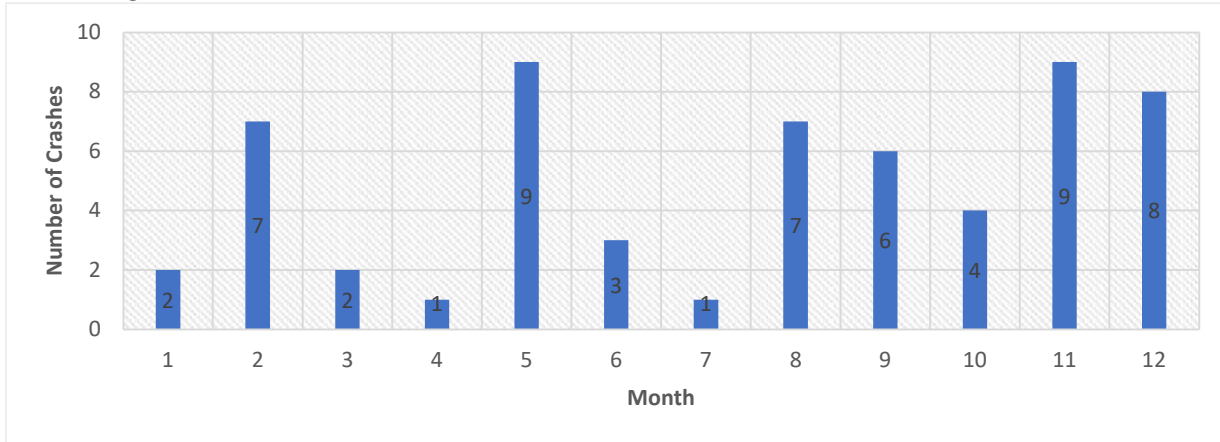
Figure 10: Frequency of Crashes by Month

The frequency of crashes by month is shown in **Figure 10**. The months of May, November and December had the highest number of crashes.

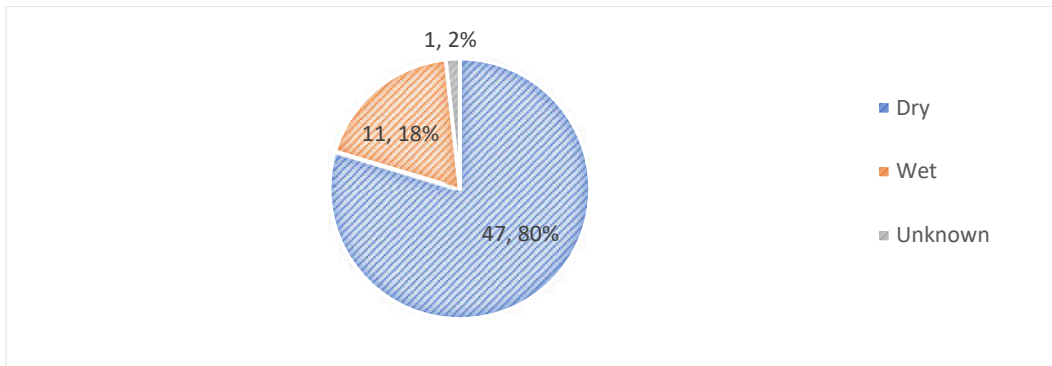
Figure 11: Frequency of Crashes by Weather

The weather condition is shown in **Figure 11**. The majority of crashes occurred on clear days (80%).

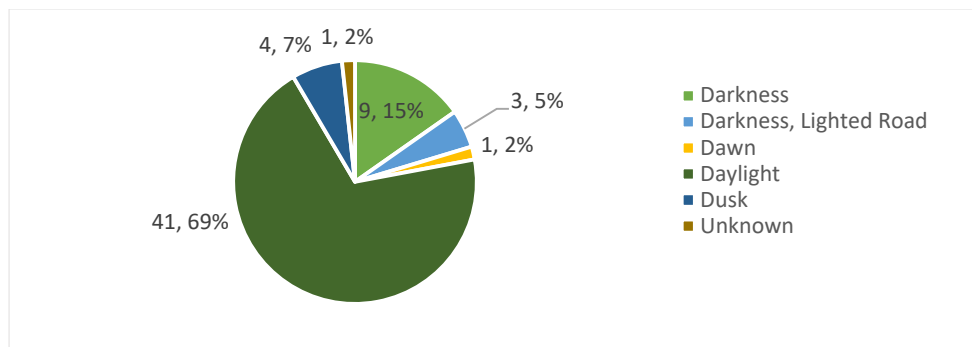
Figure 12: Frequency of Crashes by Lighting

The lighting condition is shown in **Figure 12**. Most of the crashes occurred in the daylight hours (69%), while about 31 percent occurred in the dark or during the dusk/dawn hours. A large portion of the dark crashes involved animals.

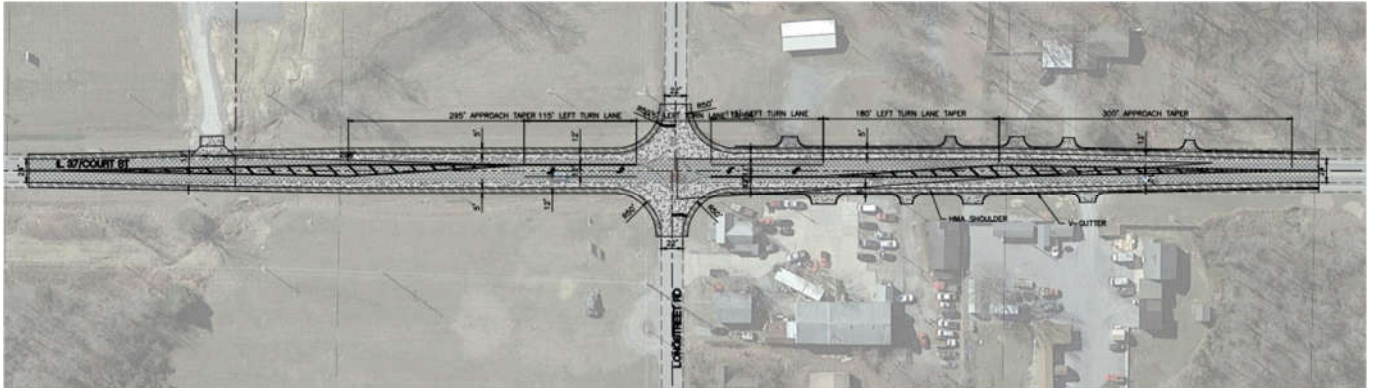
A higher cost alternative is to construct left-turn lanes along Illinois 37 at Longstreet Road to remove the left-turn vehicles from the through lane, greatly reducing the rear ends. An conceptual example of left-turn lanes are shown in **Figure 13** below.

Figure 13: Separate Northbound and Southbound Left-Turn Lanes along IL 37 at Longstreet Road

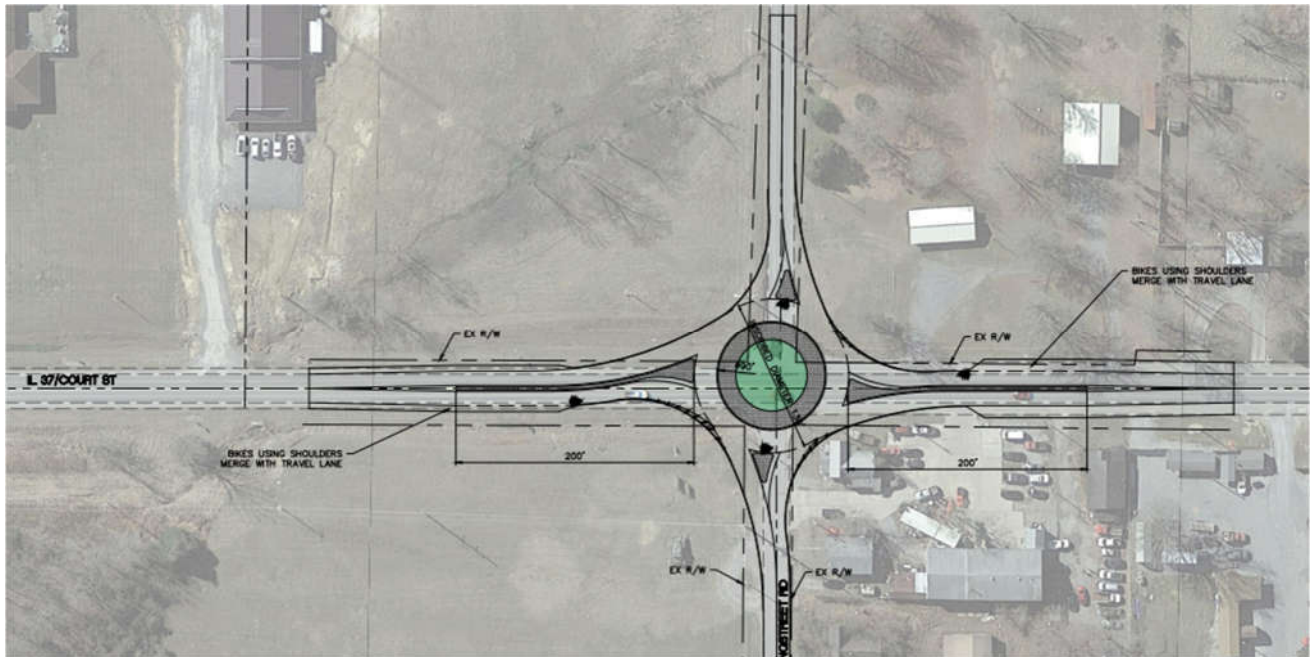
Finally, the best overall alternative is to construct a roundabout at Illinois 37 at Longstreet Road. The roundabout would address all the crash types experienced at the intersection including turning, rear ends and angle crashes. A conceptual example of a roundabout layout is shown in **Figure 14** below.

Figure 14: Conceptual Layout of a Roundabout at IL 37 and Longstreet Road

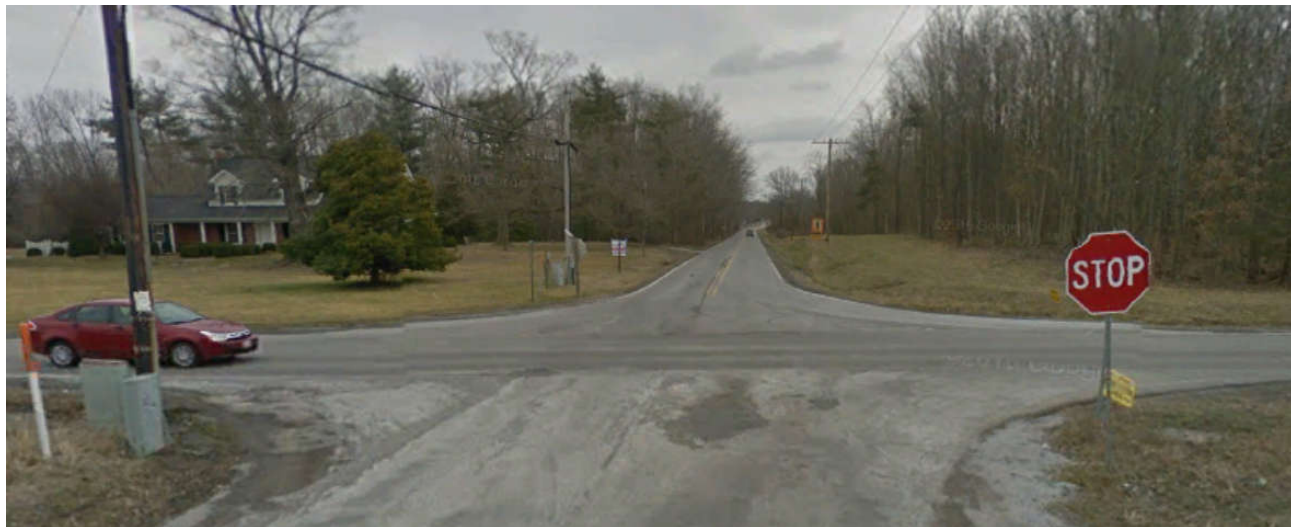
Figure 3: Intersection of Cardinal Rd/Grand Ave and Cambria Rd (Street View looking east from Cardinal)

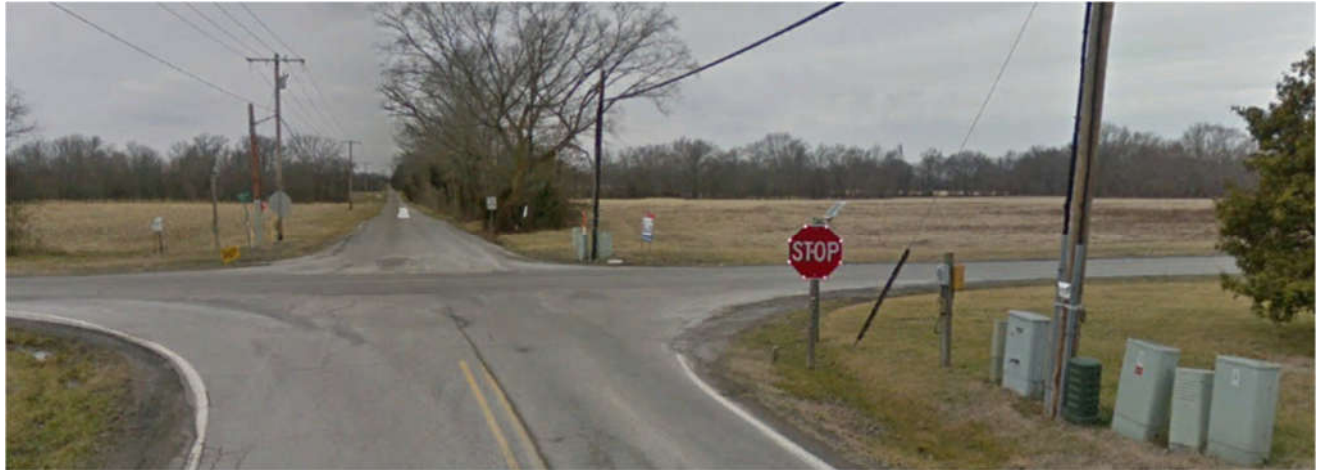
Figure 4: Intersection of Cardinal Rd/Grand Ave and Cambria Rd (Street View looking west from Grand Ave)

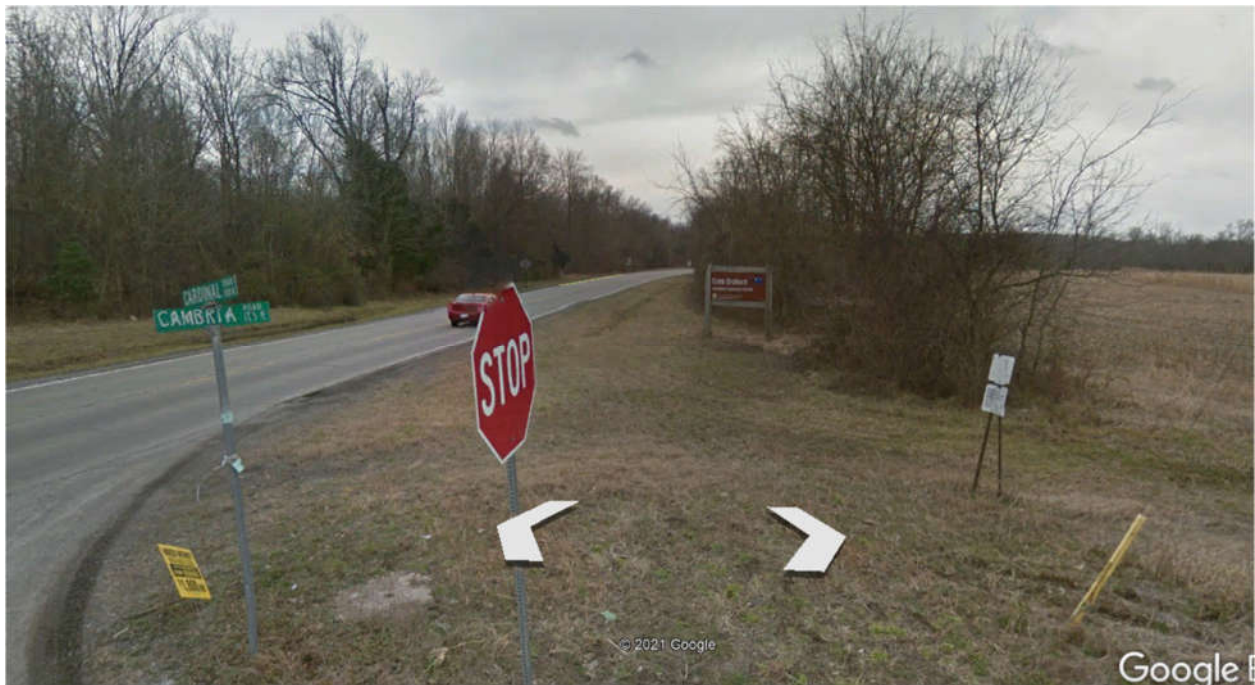
Figure 5: Sight Distance from Cardinal Rd looking South (Street view)

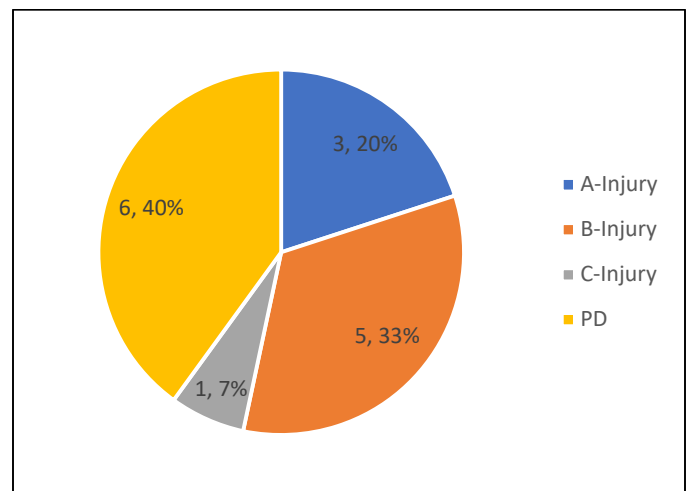
Figure 8: Frequency of Crashes by Severity

The frequency of crashes by severity is shown in **Figure 6**. 40 percent of the crashes were property damage only and 60% were injury. All three A injuries were turning crashes. One was eastbound straight with northbound right, the second was a southbound left-turn and a northbound through and the third was northbound right and a northbound through.
